Survey # WA-I-804
Street Address 13811 Village Mill Drive
Town, State Maugansville, Maryland 21767
private X, public ____

MARYLAND COMPREHENSIVE PRESERVATION PLAN DATA

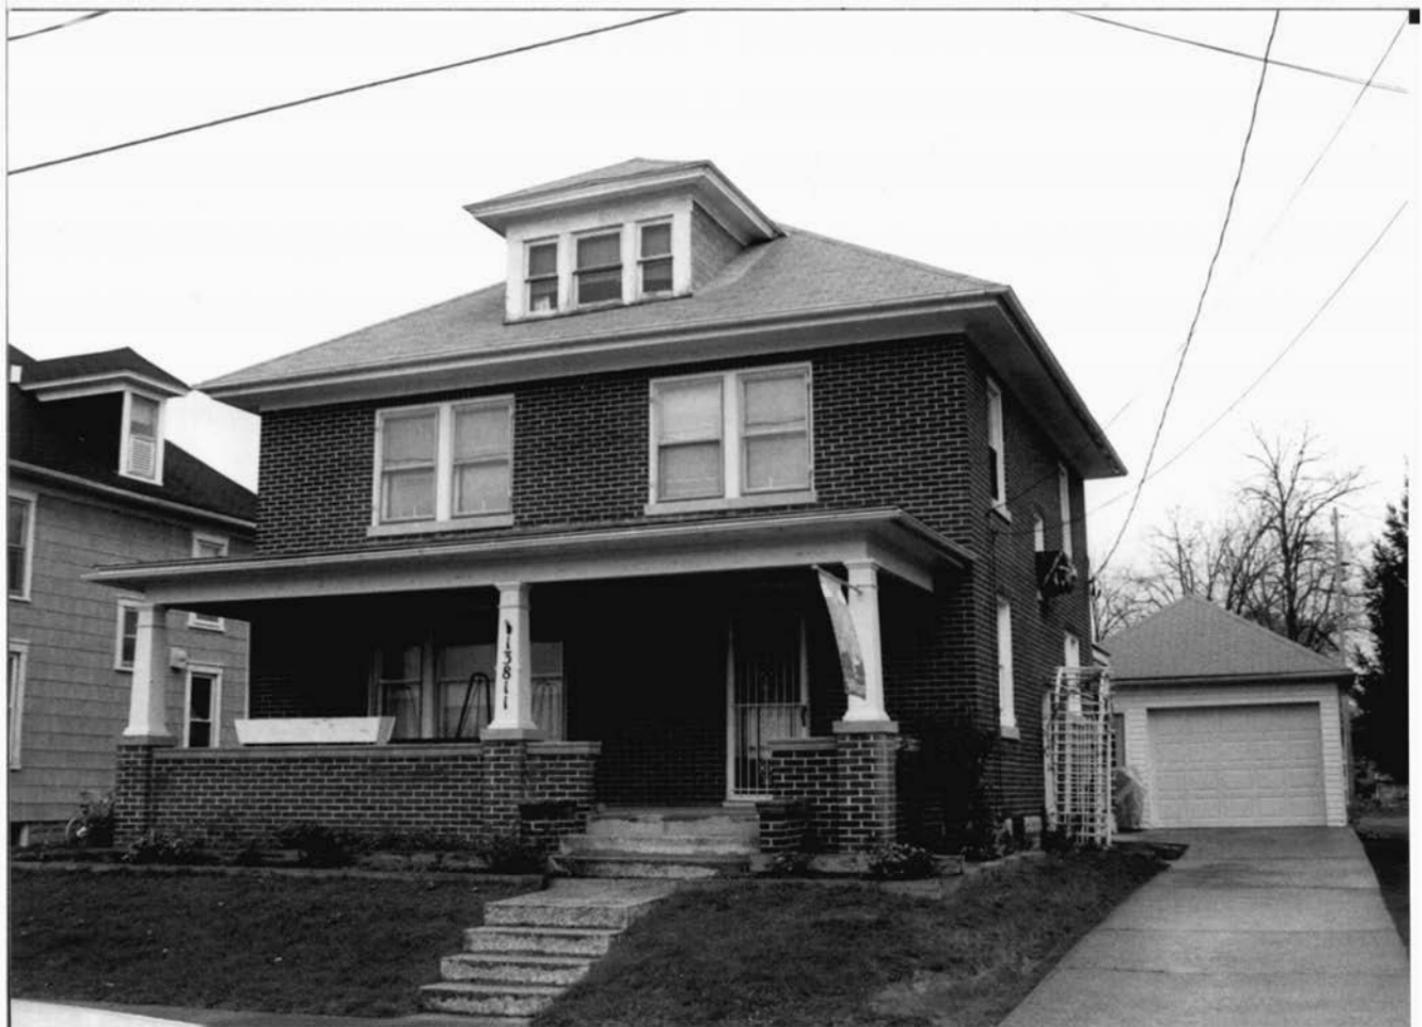
This brick foursquare style house is located on the east side of Village Mill Drive, among similar houses south of Eby Lane. It has a two bay wide facade and rests on rock-faced concrete block foundations. Bricks are laid in all stretcher bond. Windows have single pane and several are doubled. The first story front window is tripled. The house has the characteristic foursquare hipped roof with a frontal hipped dormer. A porch across the front is supported by tapered square posts resting on brick piers with concrete coping. Behind the house is a frame foursquare garage. These foursquare houses illustrate Maugansville's major growth period in the early 1900s.
