Survey # WA-II-1064 Approximate date Ca. 1870
Street Address 39 South Main Street
Town, State Keedysville, Maryland
private X, public

Description

WA-II-1064

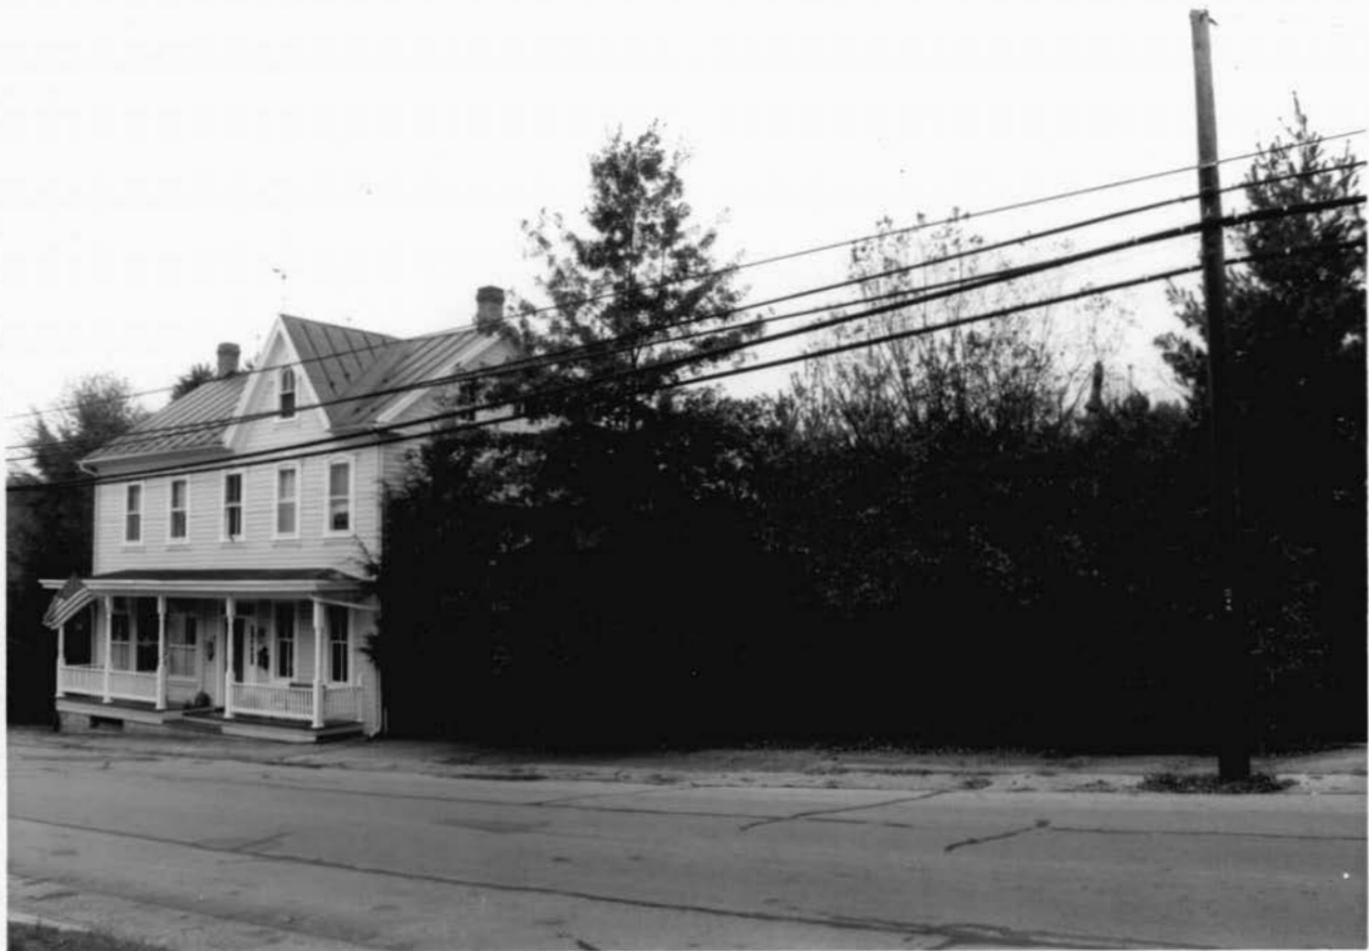
#53

This commercial and residential structure is a two story, five bay frame building with a cross gable centered over the three northern bays which made up the residential portion of the house. The building is covered with German siding. The two southern bays at the first story contain a storefront consisting of large four-pane display windows flanking a recessed entrance. The main entrance is located in the center bay. The roof is covered with standing seam sheet metal and chimneys are located inside the end walls. A porch with turned posts extend across the front.

SW view, N+E elevations
