**NATIONAL REGISTER OF HISTORIC PLACES
CONTINUATION SHEET**

WA-II-126
Cedar Grove
Washington County, MD

DESCRIPTION SUMMARY

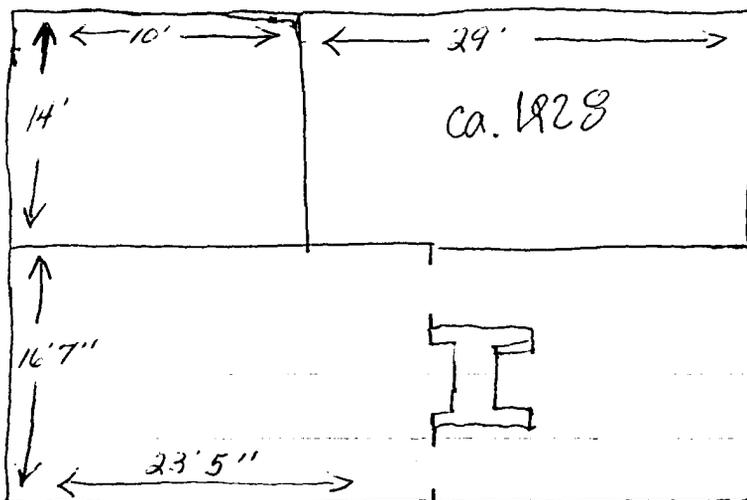
1928 Mr. Miller purchases property.

1. Adds northwest frame in fill.
2. Brick veneers hws.

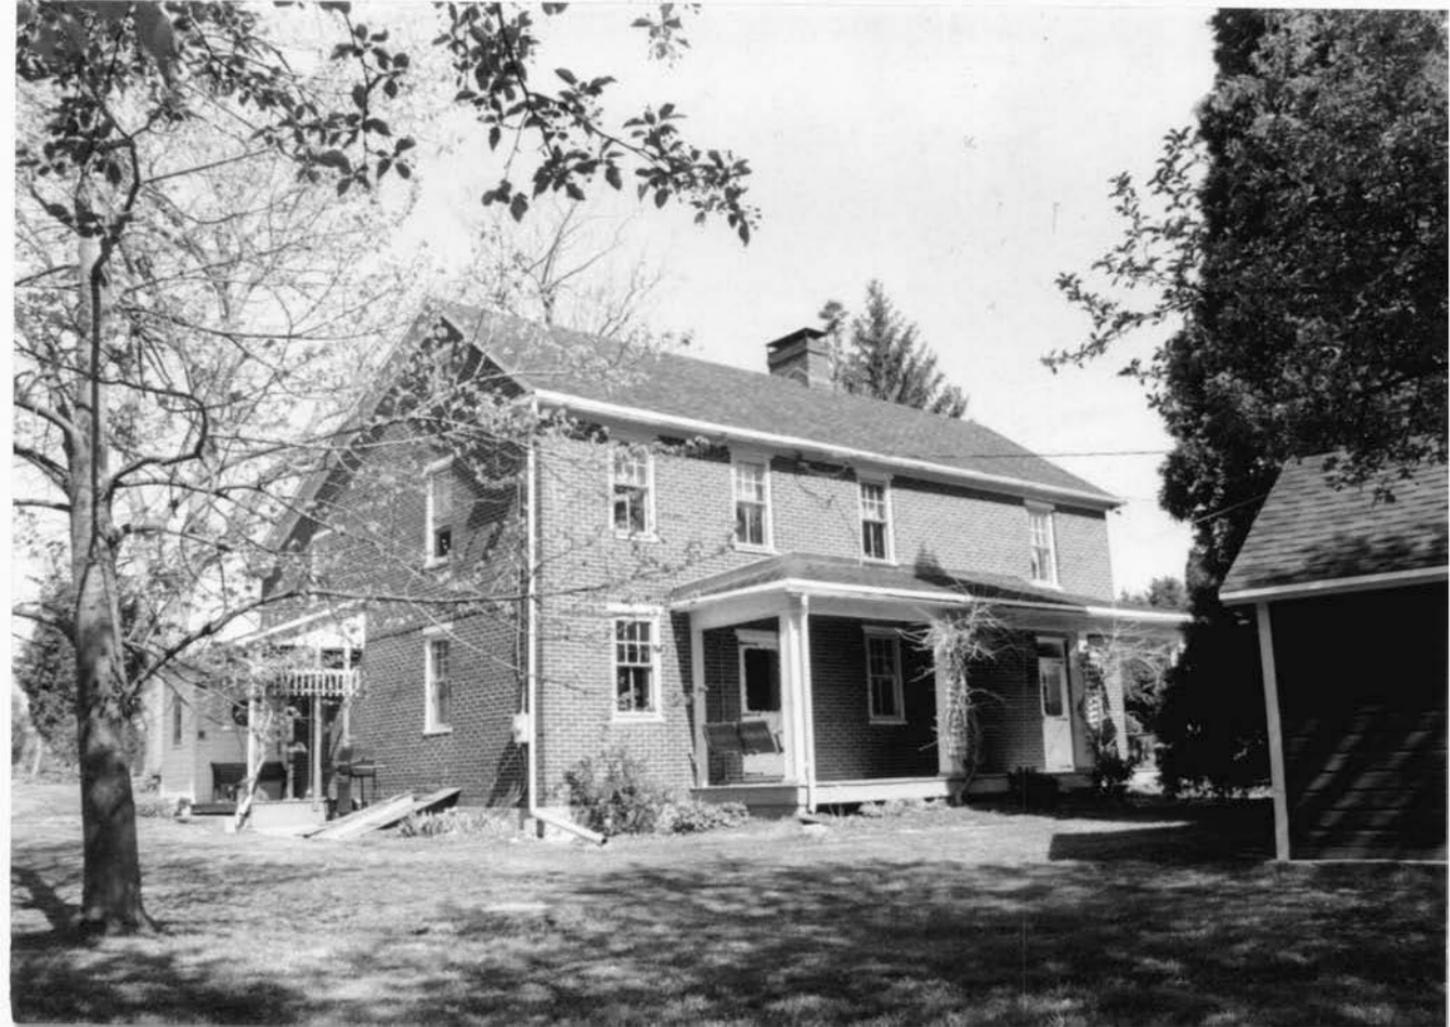
1 of

house, NW view

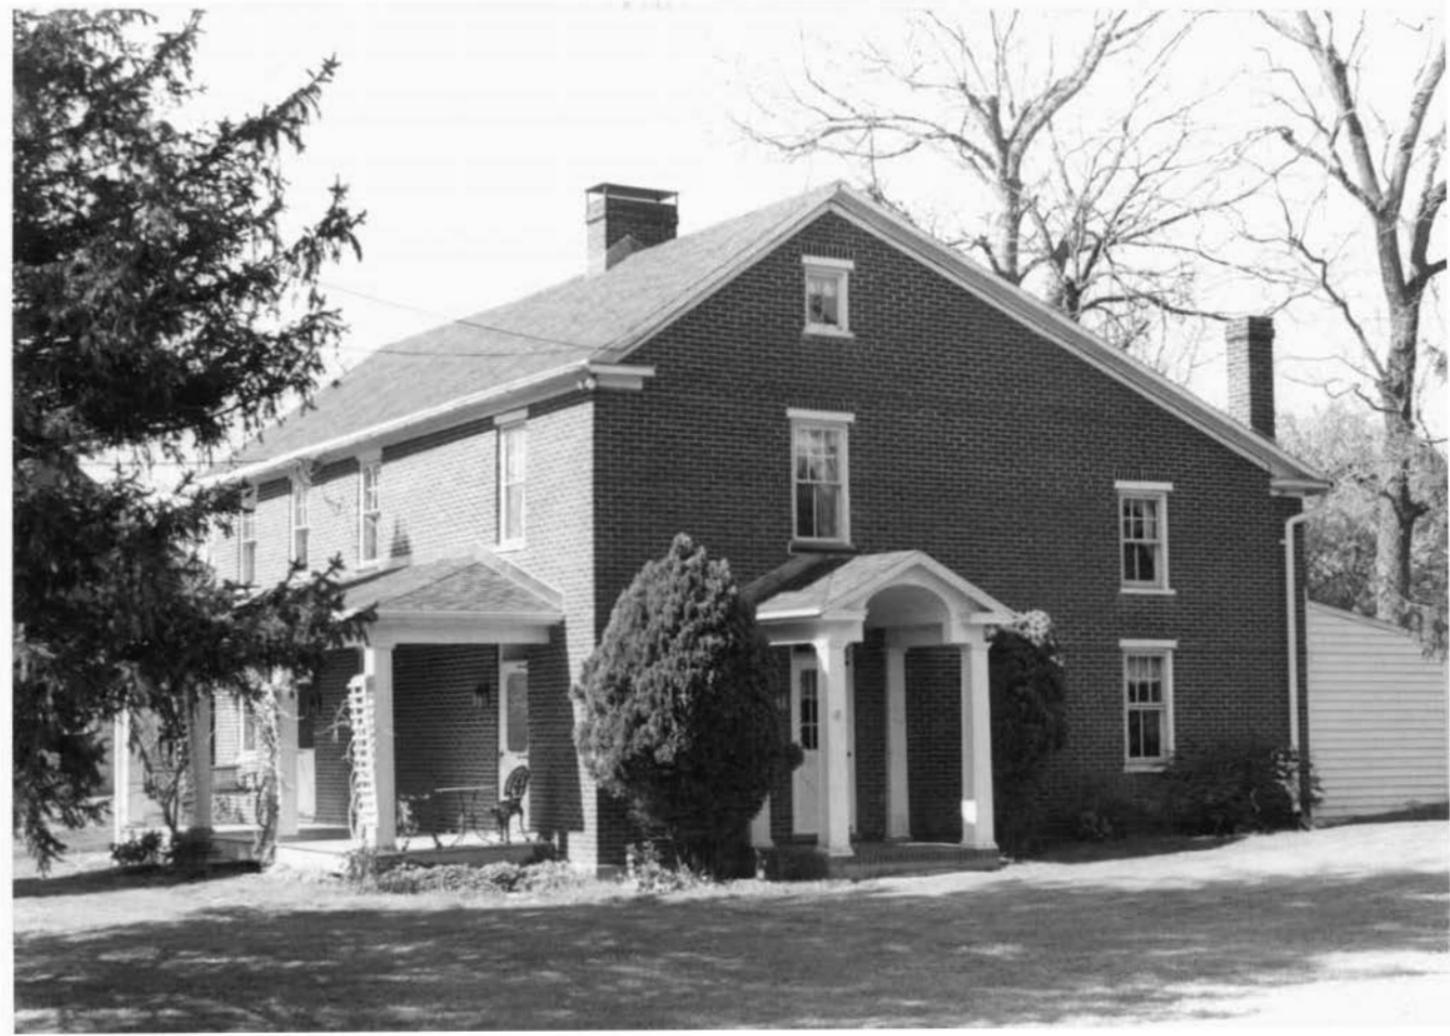
#2 of 2

House, SW view

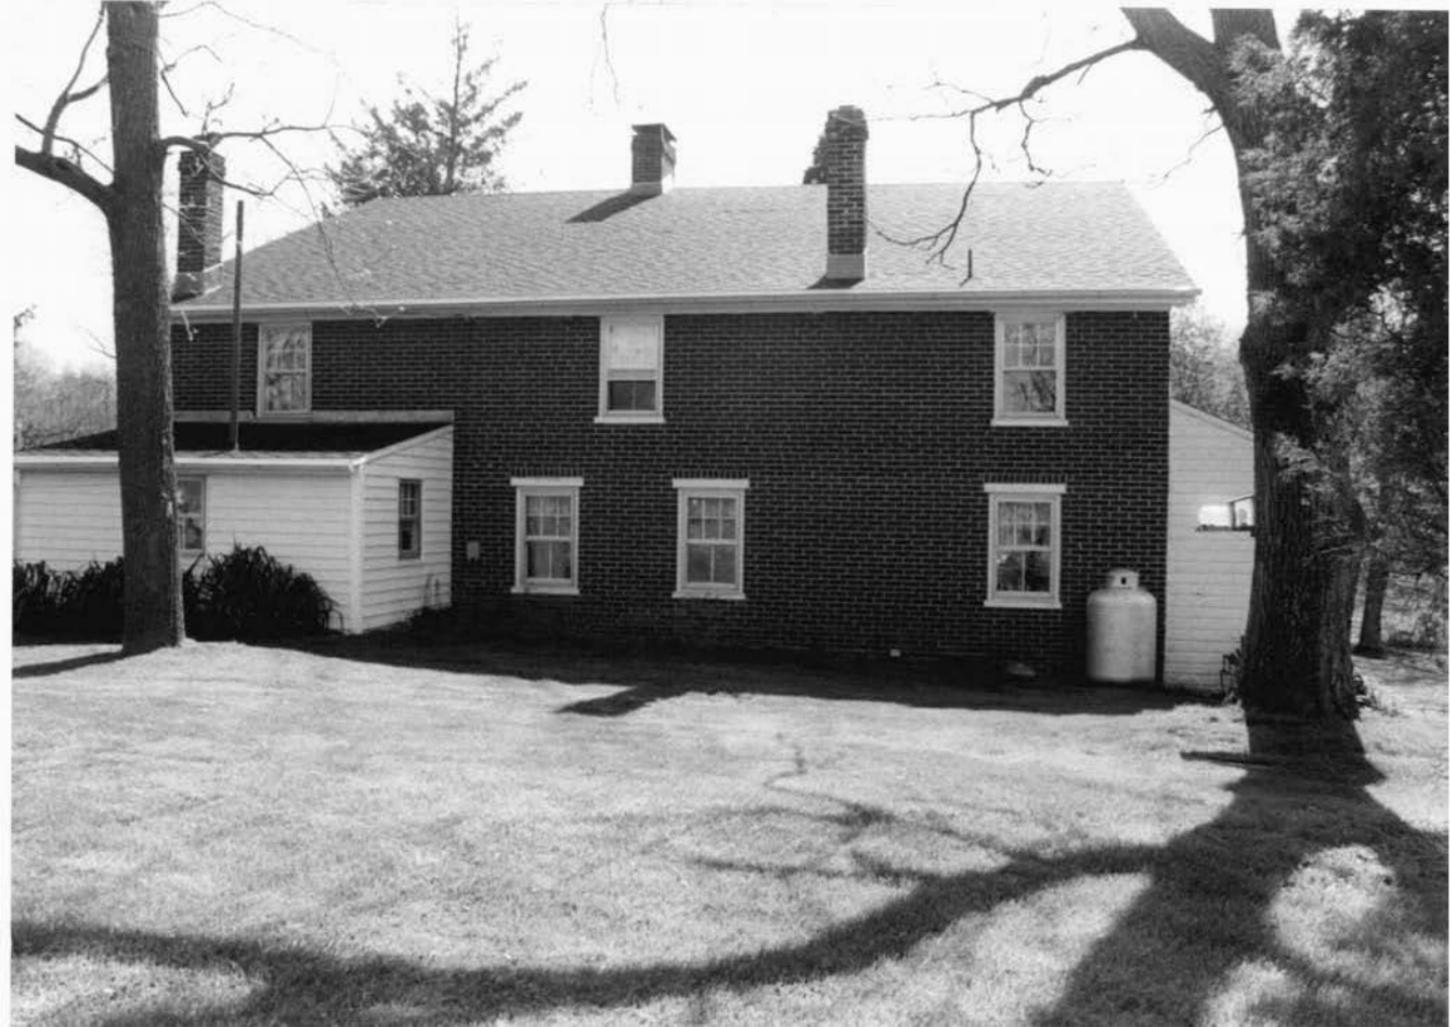
#1 of 23

House, E. View

The house in the complex is located near the south edge of Dellinger Road and faces east. It is a two story, four bay brick-cased log dwelling with a central chimney, the portion of which that extends above the roofline is brick. The chimney at the first story is stone. Leanto additions have been attached to the rear (north) elevation of the building which causes the west slope of the gable roof to be longer and shallower. Another leanto addition, one story high and wood sided, is attached to the north elevation.

The openings in the front elevation are grouped with three bays to the south of the central chimney. This section at the first and second stories forms two of the four separate components of the house. The window and door arrangement across the front elevation is window, door, window, with the section north of the chimney having only a door at the first story. These openings are aligned with four windows across the second story front. Windows have wide wooden lintels with six over two light sash which were installed in 1928, replacing earlier nine over six light windows. Entrances are located in the second bay from the south end of the front, and in the fourth bay, and in the two gable end walls. The entrance in the second bay from the south end has a door with six raised panels with molded

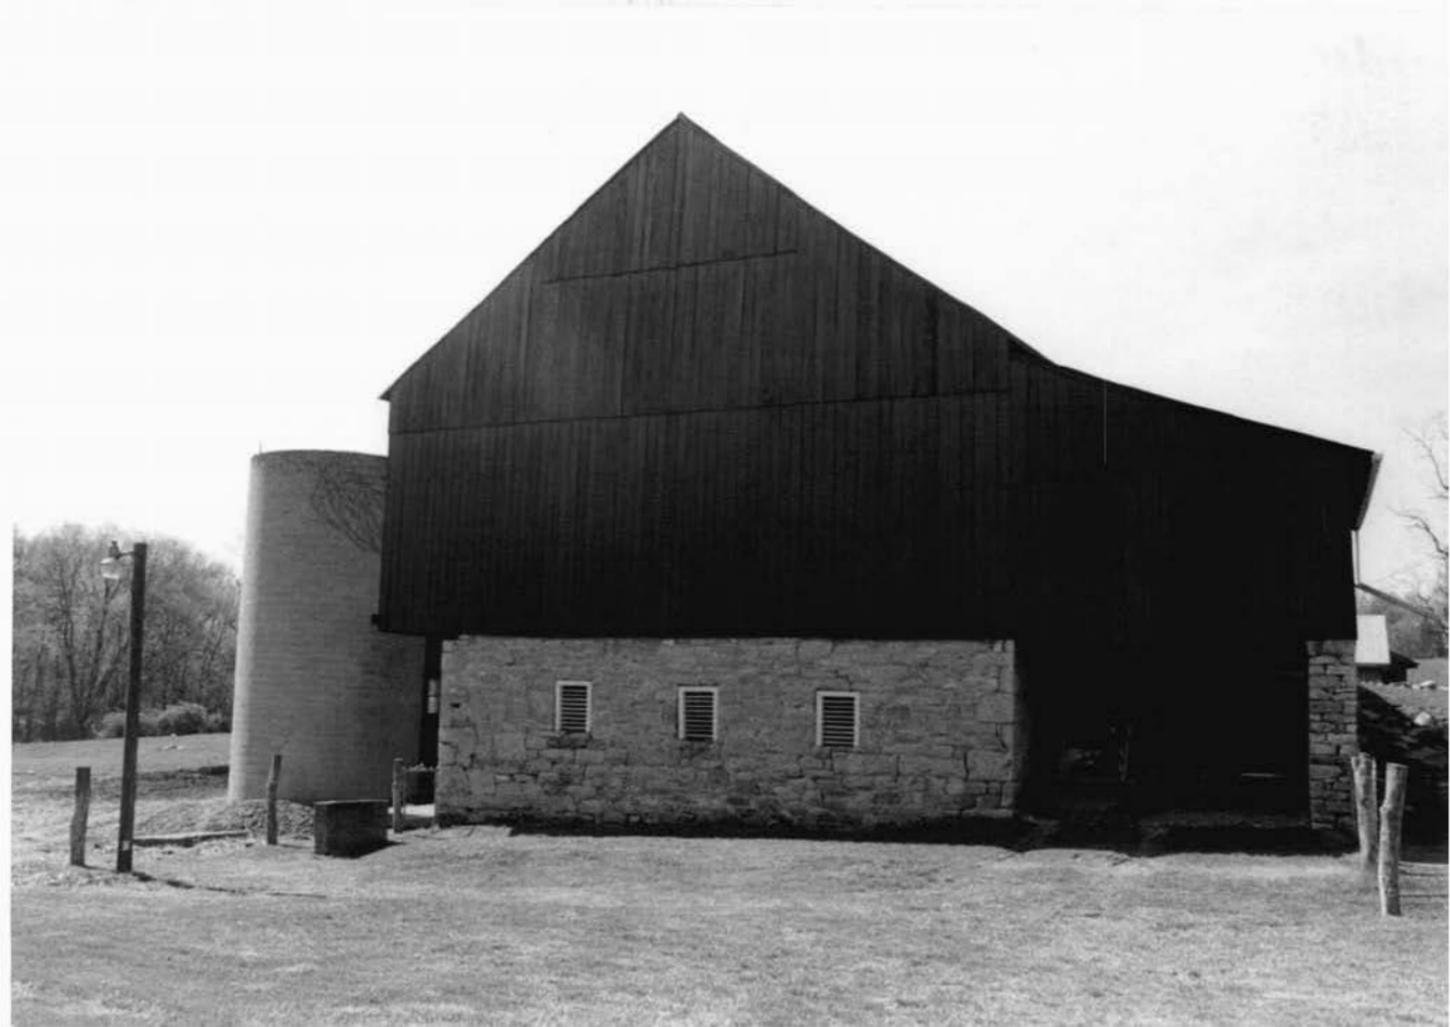
#6 of 23

Barn. W. view

The existing outbuildings on the property appear to date from the early 19th century or later. The barn is timber framed with pegged joints and vertical board siding. It rests on stone foundations with small windows with pegged frames. The roof is steeply pitched. The spring house is stone with a gable roof, also with small windows with pegged joints. The other buildings are framed and date from later in the 19th century or the early 20th century. All remain in excellent condition. The barn foundation and springhouse have been repointed recently.

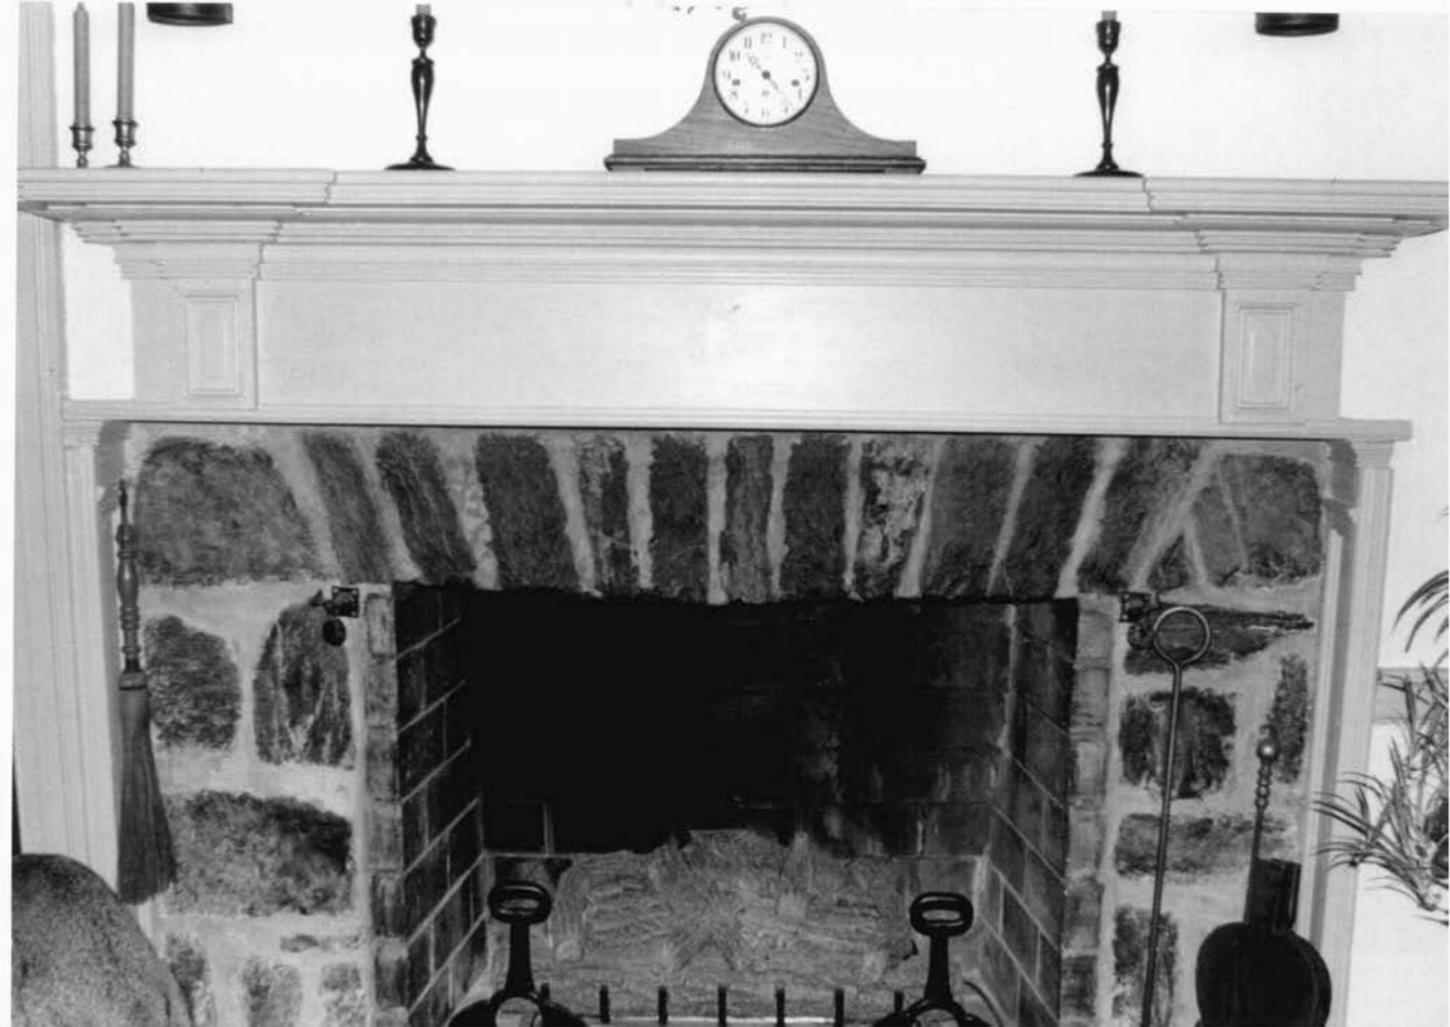
#13 of 23

109. 100 P. in. 10/20/2000 Magnolia's on 11/15
10/20/2000, DE 100, Fireplace

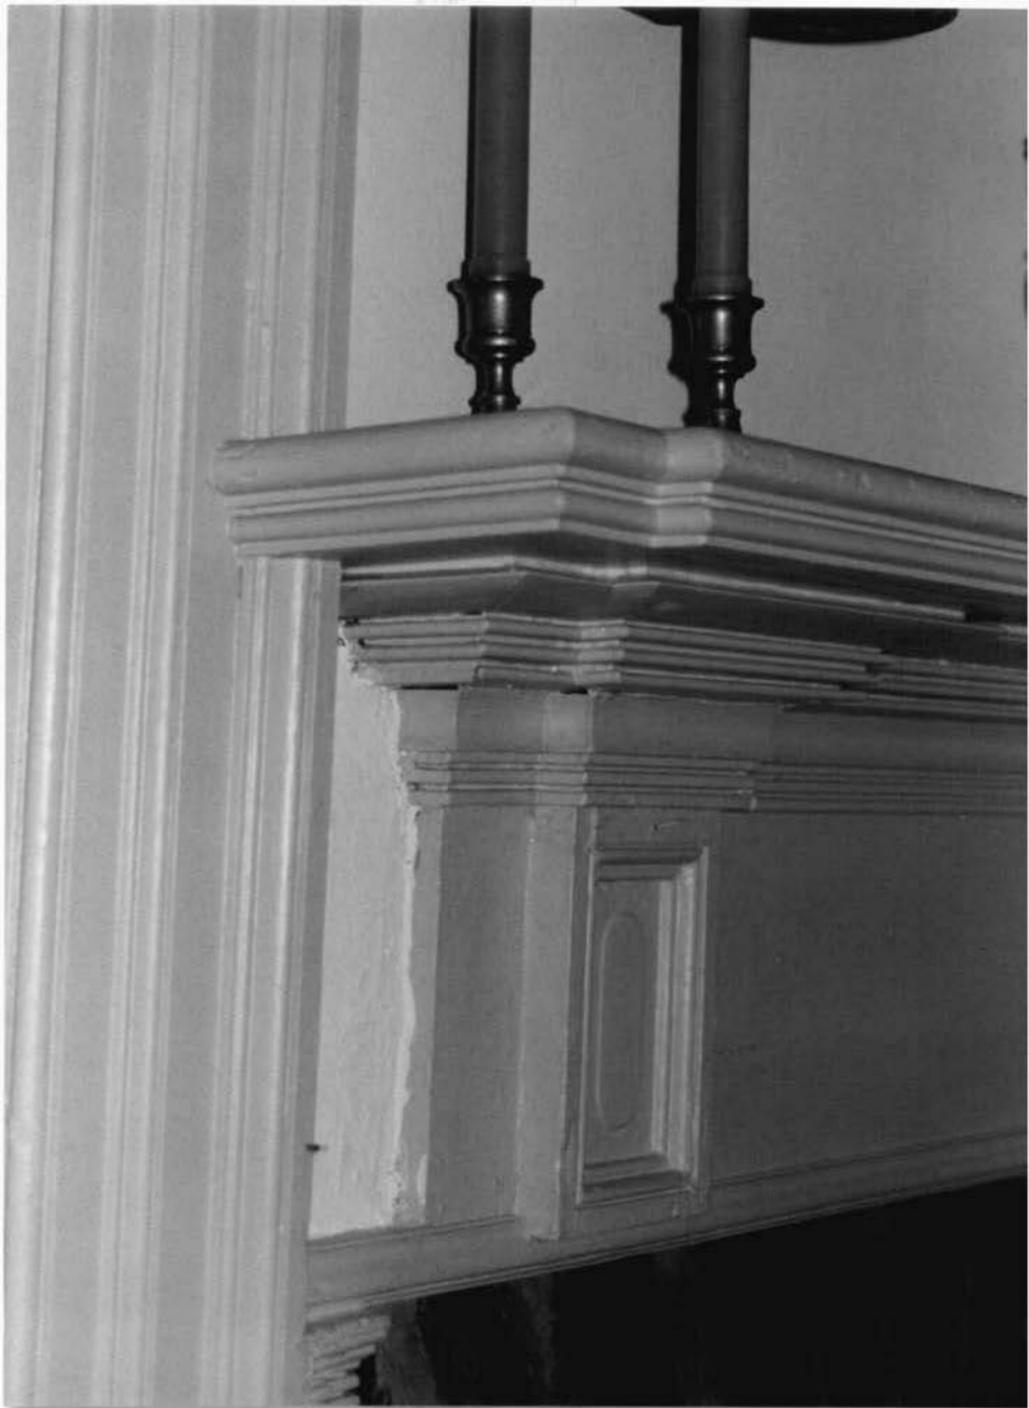
#15 of 23

Intero. SE Room. Five 100 woodwork

The original log section is one room with a central entrance in its east wall and a fireplace in the north end. Its interior dimensions are 16'7" by 23'5" which would make the exterior dimensions approximately 19' by 25.' The room is outfitted with chairrail with double molding, doors with six molded panels and architraves with double ogee moldings. The door to the second floor retains original grain painted finish, finely done to resemble tiger maple. This high-quality interior graining is associated with workmanship of the early 19th century in Washington County. Although altered in the 1960s or '70s, the fireplace retains its early 19th century Federal style mantel. It consists of a shelf with several layers of deeply cut moldings, molded pilasters with inset oval panels over the stone firebox. The original plaster fire box finish has been removed. The floors in this section also appear to be part of the early 19th century renovations. They are of fine quality, vertical grained heart pine of fairly uniform and narrow widths (approximately 5 inches), blind nailed through the tongues of the boards so the floor nails don't show.

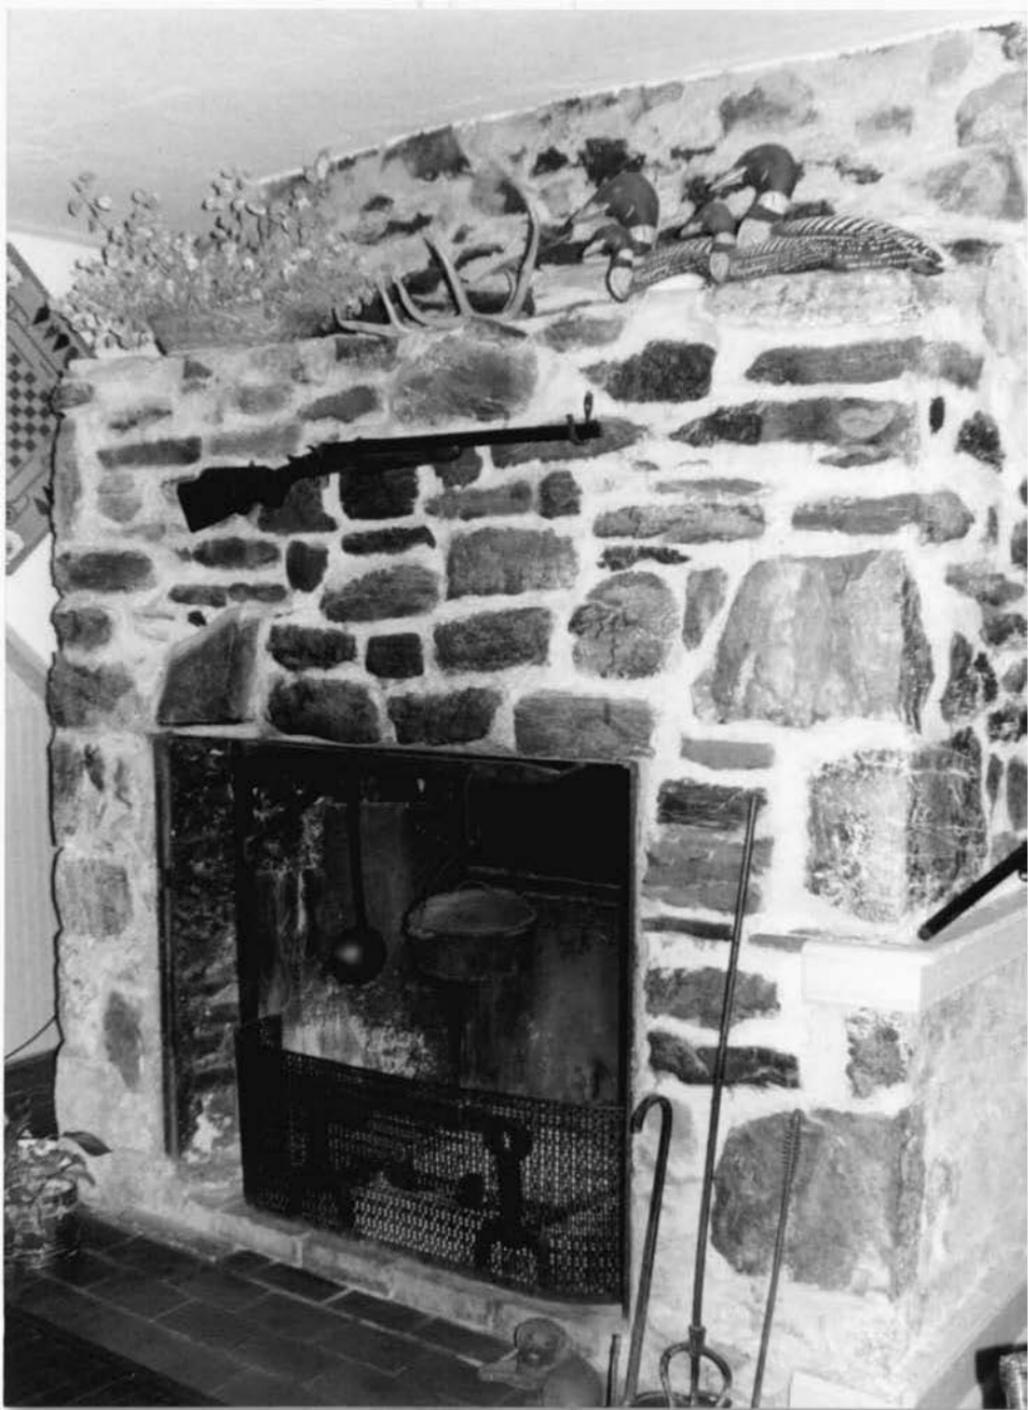
#18 of 23

Interior Fireplace, NE room

The interior dimensions of the second room are 16'7" by 15'7." The space is dominated by the large stone fireplace constructed as part of the original chimney system. This room is also outfitted with chairrail, but not as finely molded as that used in the first room.

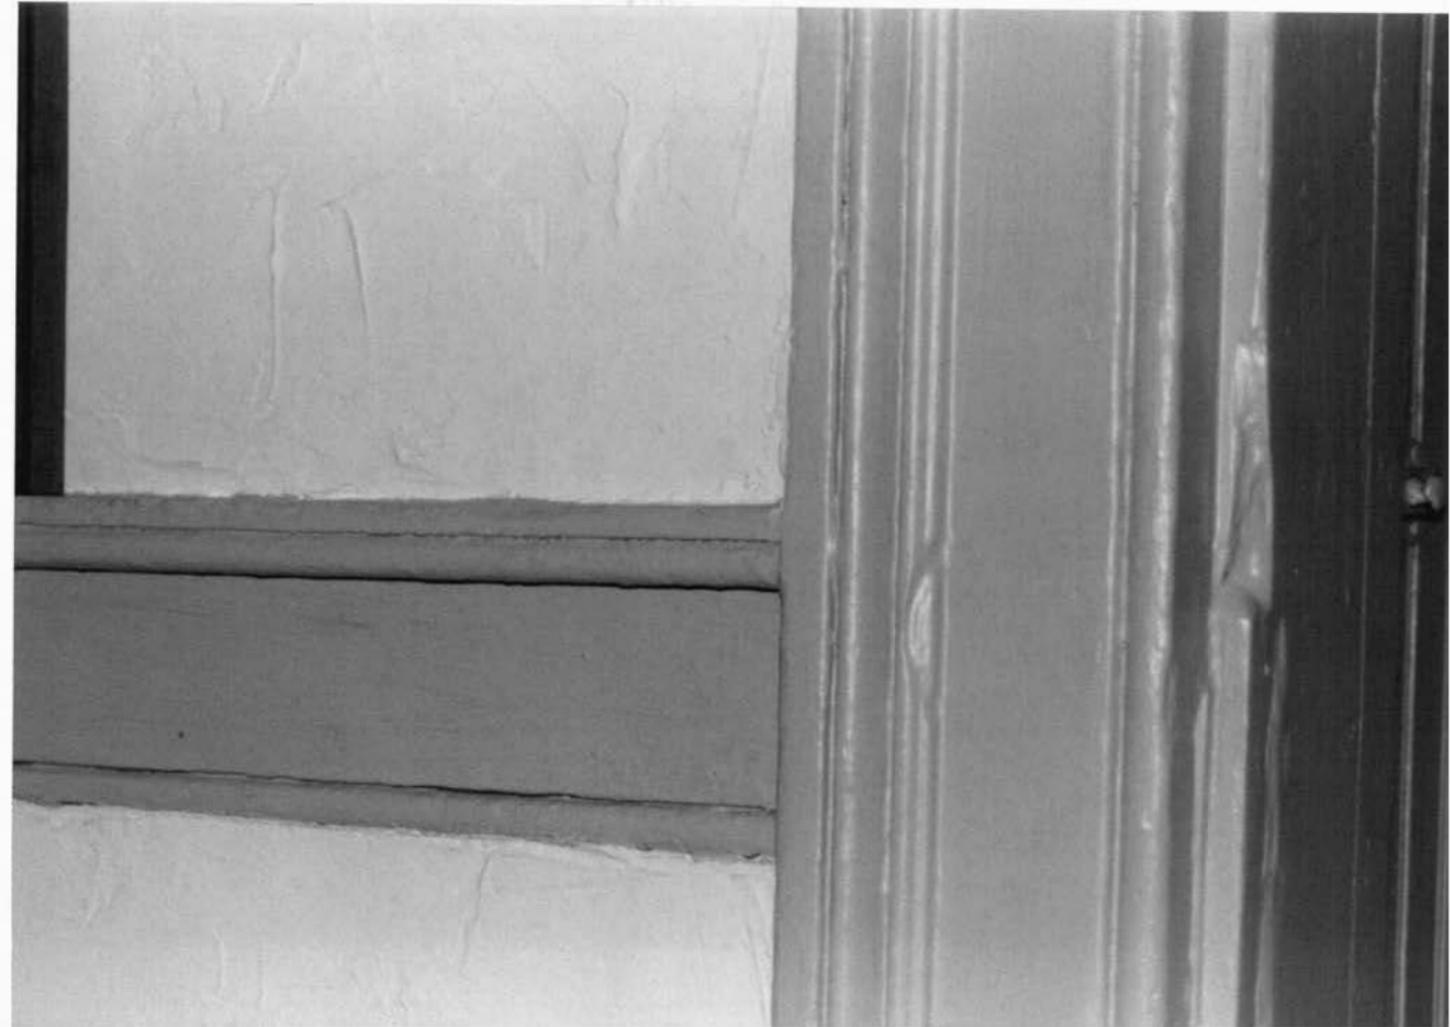
#19 of 23

near loc. P. Reed + Assoc. Inc, Hagerstown MD
char rail and Archtrave, NE room
