ABSTRACT
WA-II-180
Stone Farmhouse
Hagerstown Vicinity
private

INVENTORY FORM FOR STATE HISTORIC SITES SURVEY

Stone Farmhouse

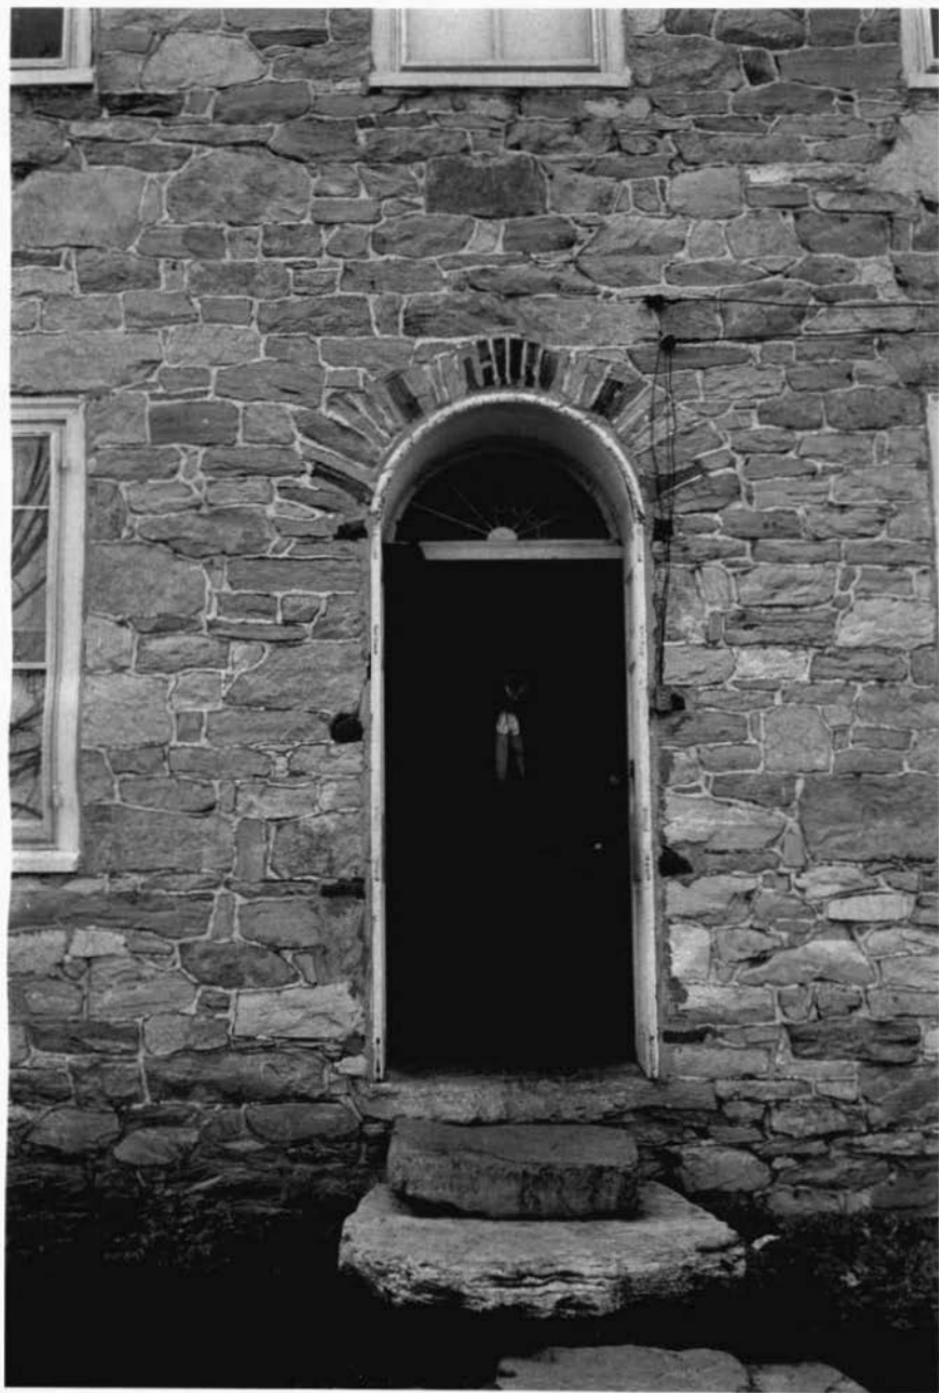
E. Detail

The main entrance is located in the third bay from the south end or the center of the forward five bays of the front elevation. The entrance has a semi-circular arched top formed by an irregular structural arch of stone, brick and wood. Lining the arch are pieces of wood to which is applied a thin veneer with a reeded surface. At intervals along the jambs and around the arch are wooden nailing blocks onto which was secured a wooden entrance piece which has since been removed. Filling the arch above the door is a semi-circular fanlight with delicate ray muntins with curved decorative work between the rays. The door has six raised panels and paneled jambs. Large round cut stone blocks provide steps to the entrance. Other doors much plainer in appearance are located beneath the double porch in the second bay from the north end at the first and second story levels. The double porch is supported by chamfered square posts and is enclosed with a plain balustrade.
