WA-II-192

"Garron's Loss"

Beaver Creek-Hagerstown Vicinity

INVENTORY FORM FOR STATE HISTORIC SITES SURVEY

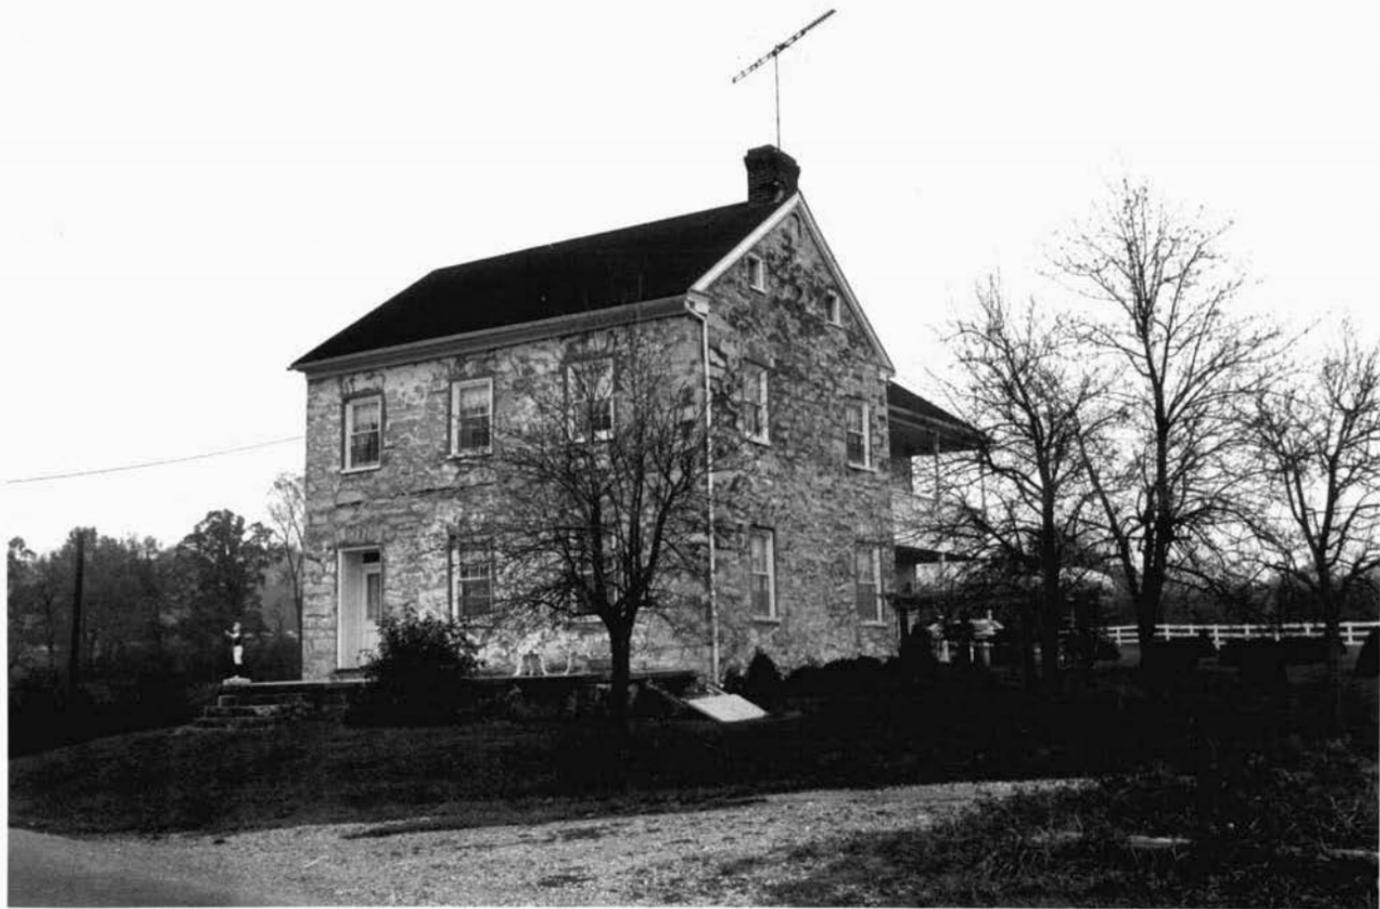
S.E.

The structure is a two story, three bay stone building with a two story, three bay modern frame ell extending to the rear. The house was destroyed by fire in the 1930's according to the owner. Therefore all interior and exterior work is modern. All that remains of the original house are the four stone walls with their window and door openings.

The surface of the house shows evidence of having been white washed, but it is not known whether or not this was the original treatment of the building. High flat arches of stone some of which appear to have a slight curved shape are present above the window and door openings. Segmental arches lined with brick are present above the attic level openings. Arched top tablets, presumably for dates are set high in each gable. One datestone is inscribed with the year 1823 which, according to the owner was put there by a mason and bears no relationship to any historical data.

Windows have been replaced with six over six pane sashes at the first and second story levels. The main entrance is located in the west end bay of the front elevation. In the east end wall there are two windows at each story level. In the west wall the only openings are two small windows in the gable.

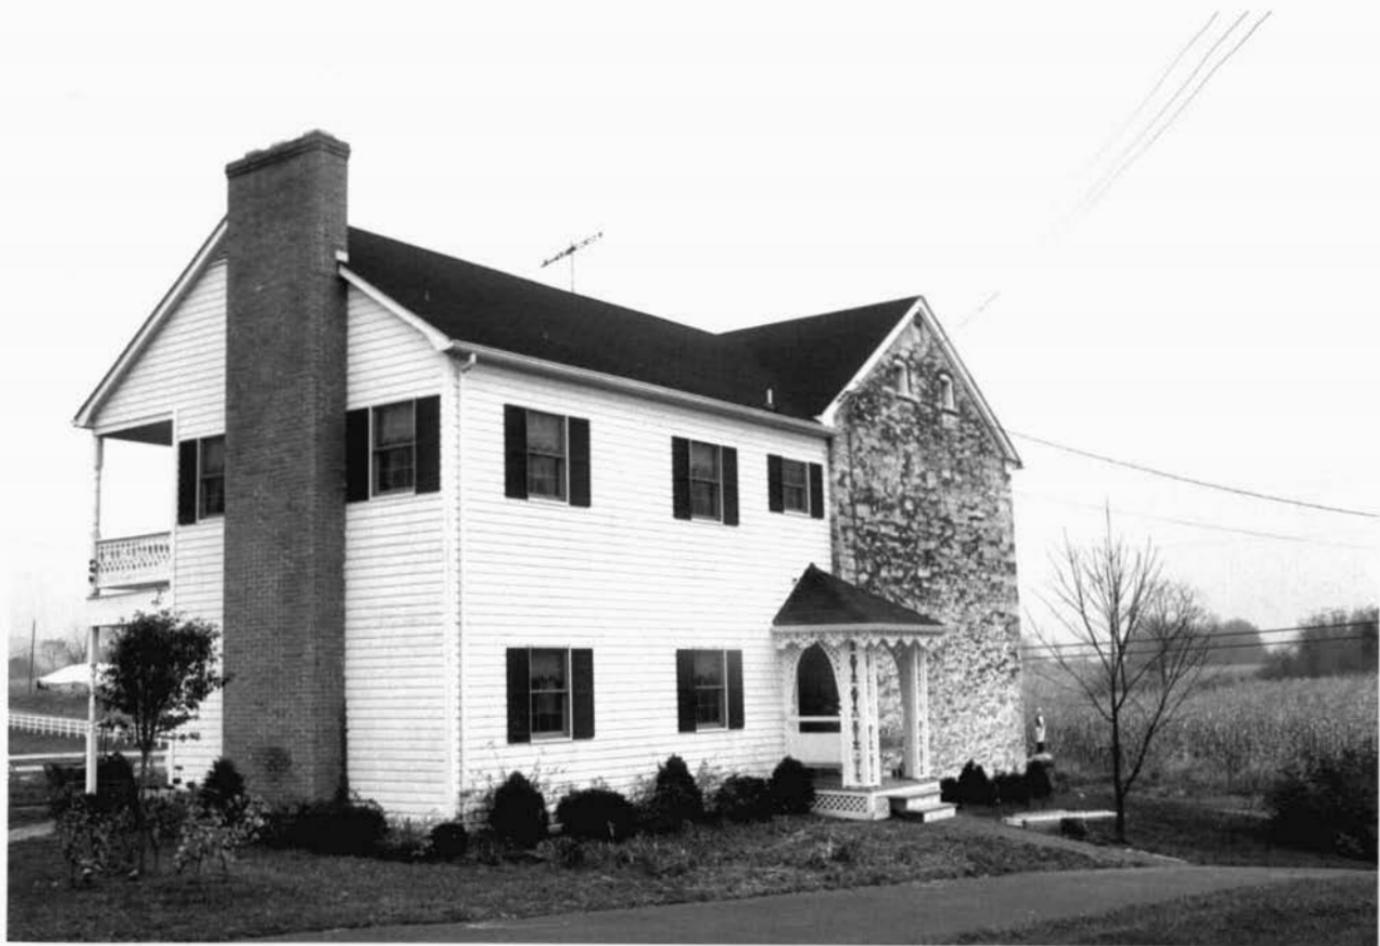
N.W.

The modern wing is patterned after a traditional regional type, with a two story porch included under the main roof span at the east elevation. The Victorian style woodwork on this porch and a small entrance porch at the west wall of the wing is all modern made by a local craftsman. Apparently this addition replaced an earlier Victorian period wing.

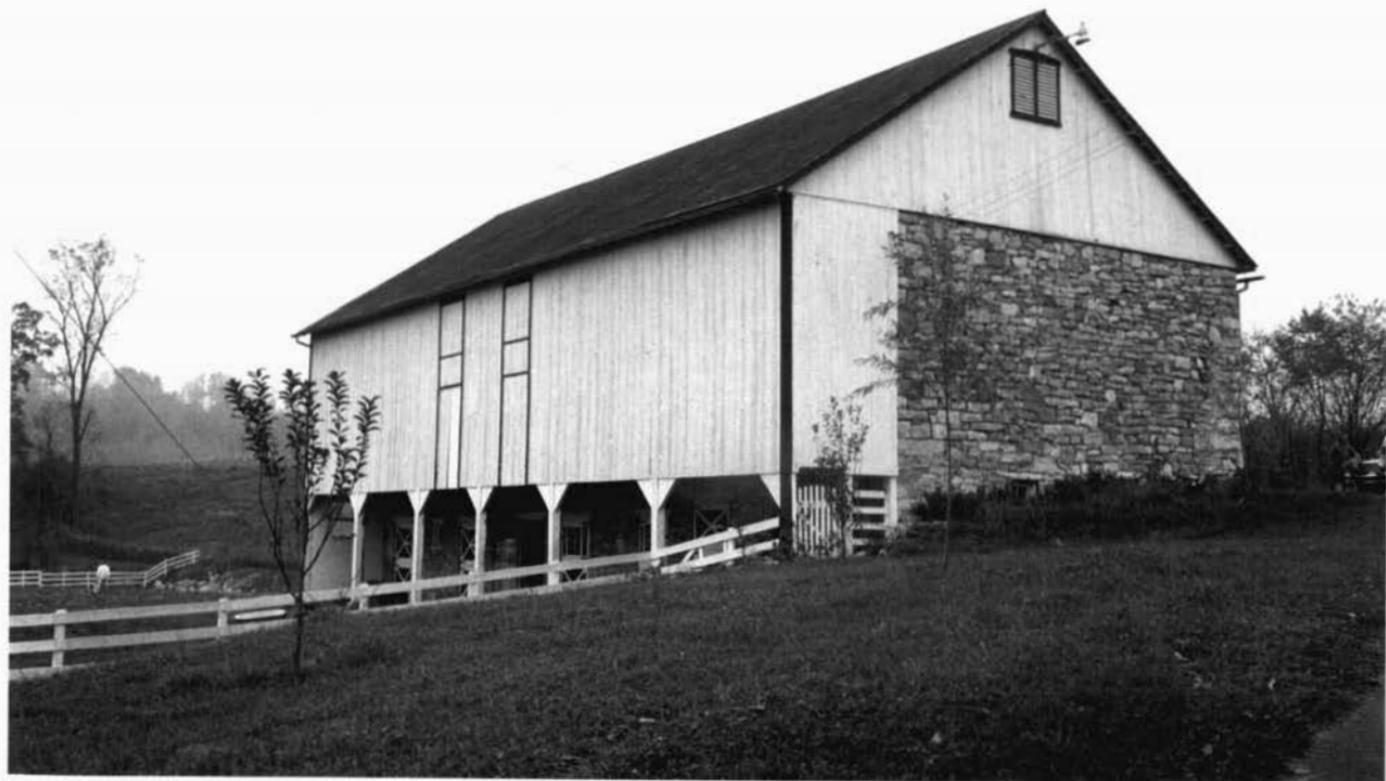
Barre S.E.

West of the house is a stone end bank barn with frame gables and a frame overhang or forebay.
