**NATIONAL REGISTER OF HISTORIC PLACES  
REGISTRATION FORM**

historic name Hoffman Farm

other names/site number WA-II-251

street 18651 Keedysville Road

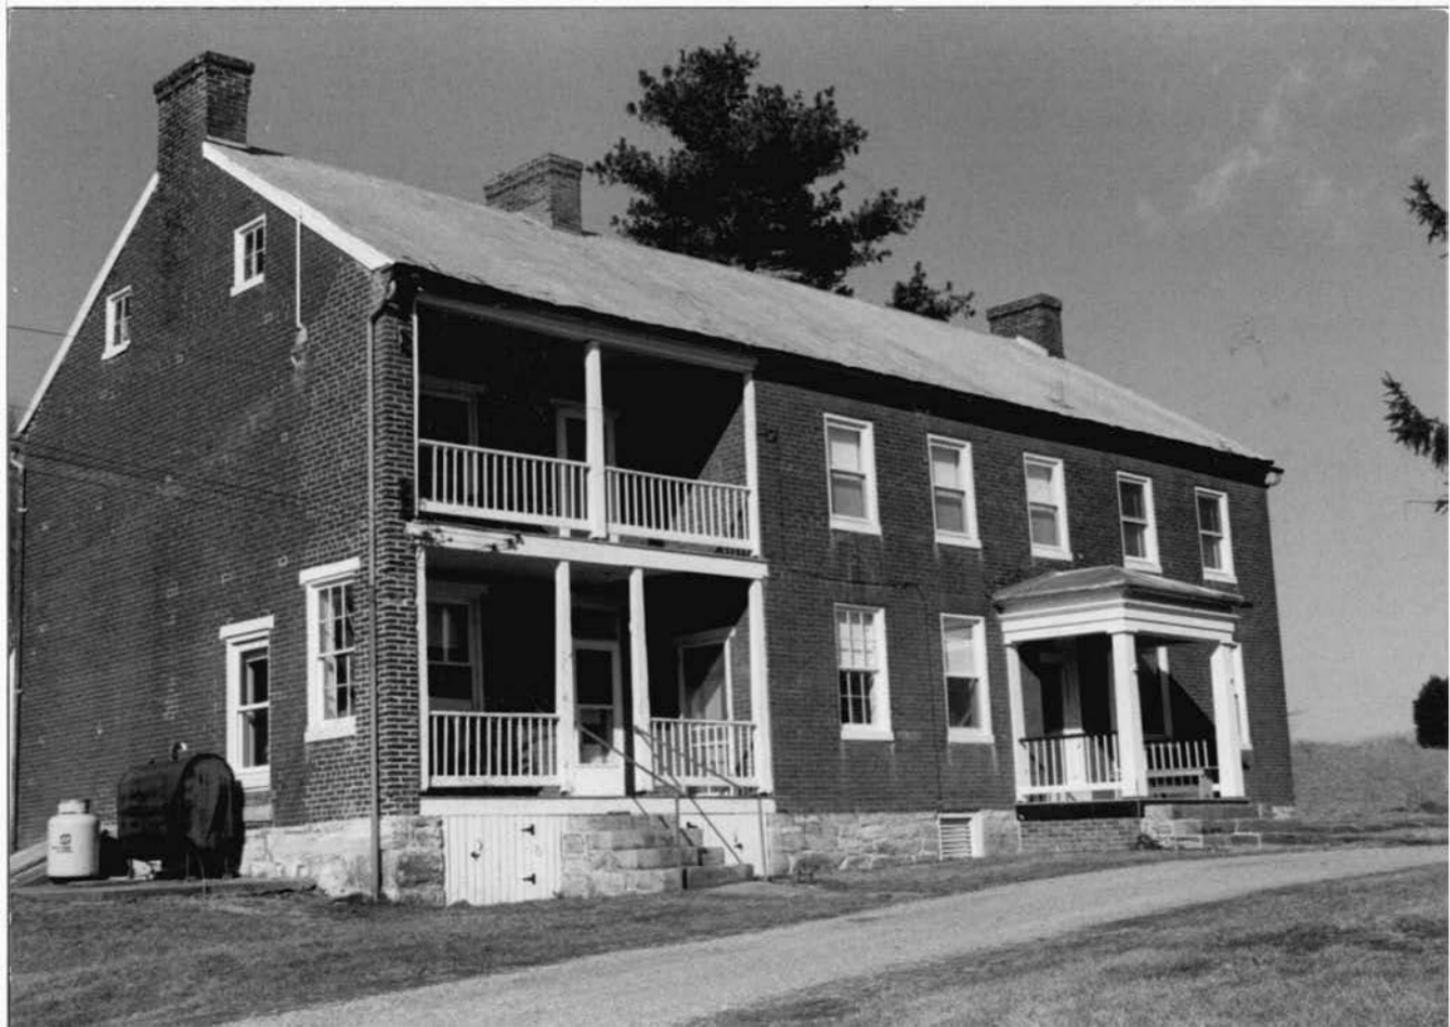
#1

NW view

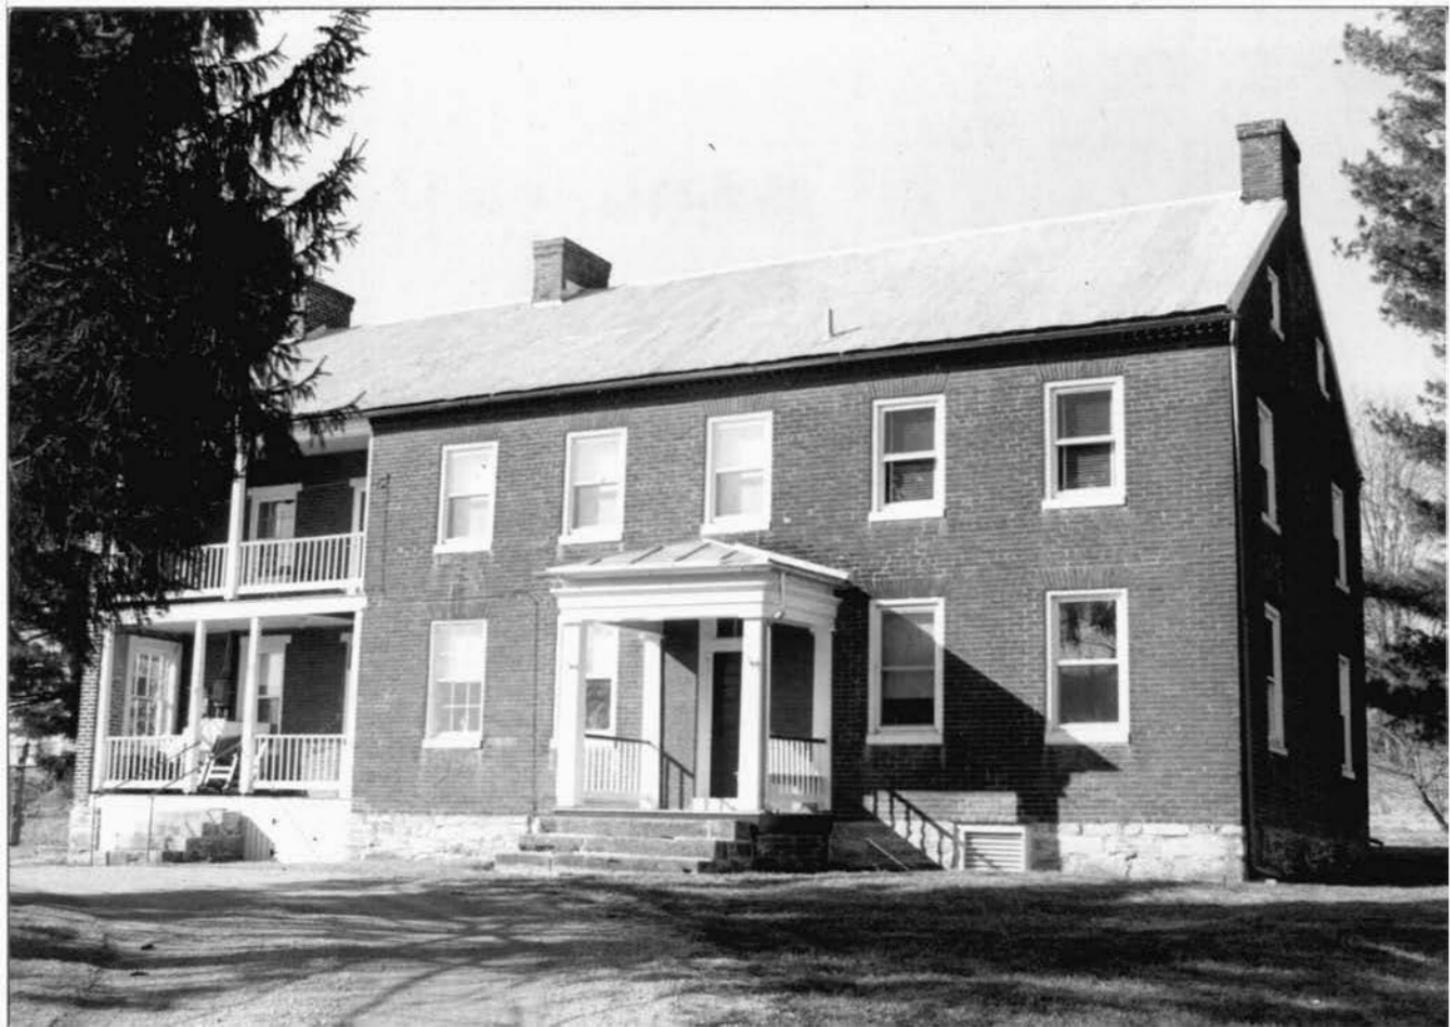
#2

SE view

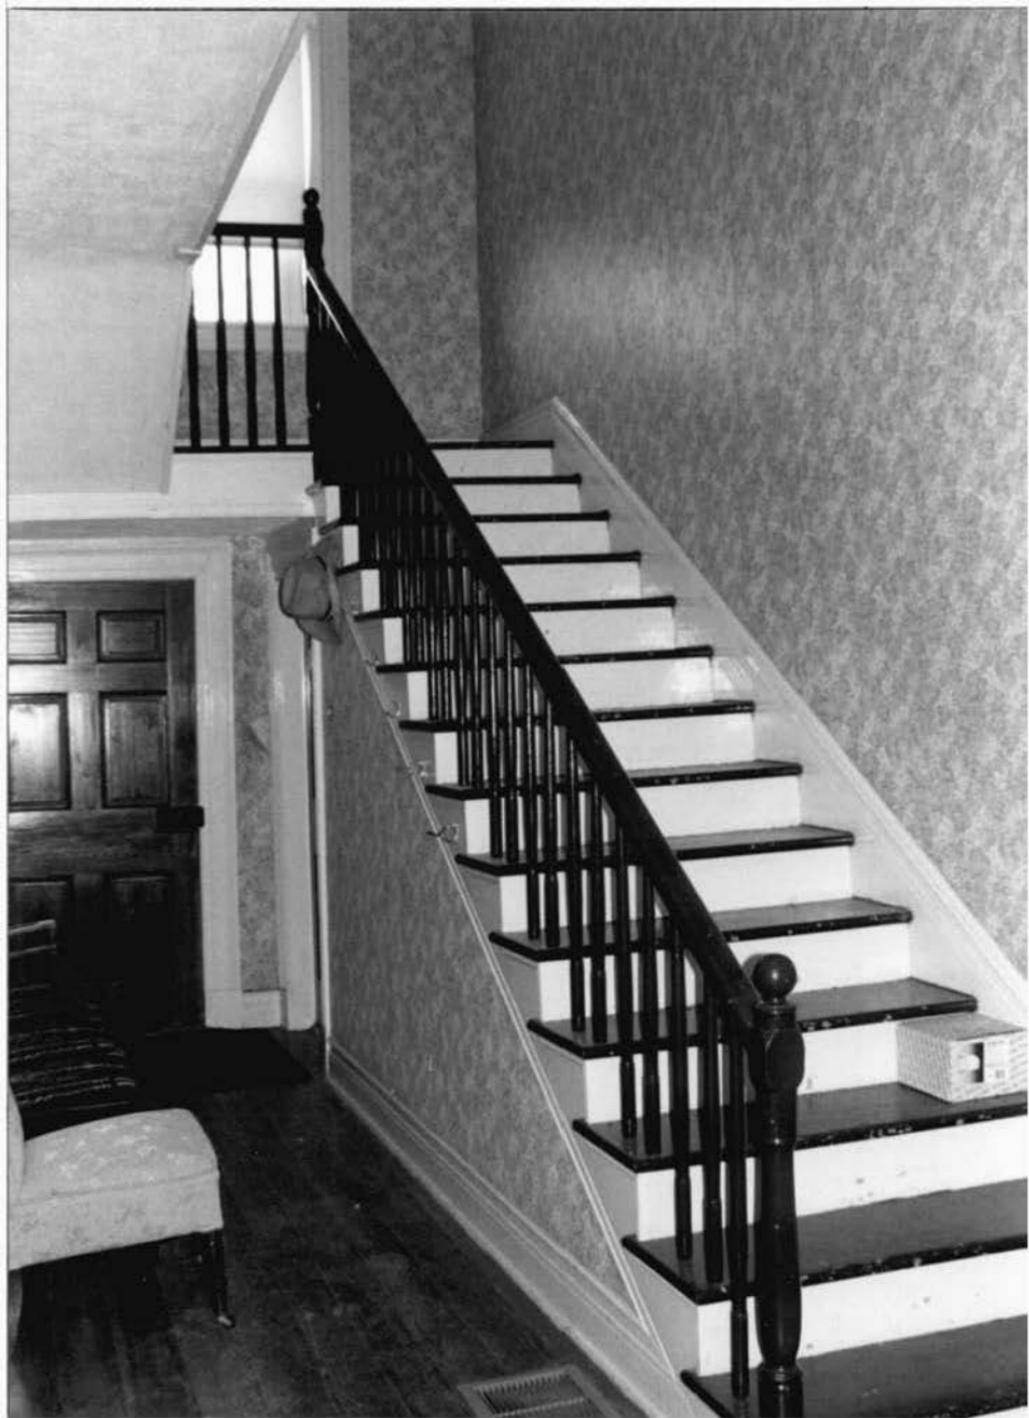
# 4

Interior main stairs, brick house

Most rooms retain original chairrail, quite low on the wall, six panel doors with original grain painted finishes, and much original hardware. The focal point of the stair hall is the staircase which ascends along the north wall of the hall. The staircase has a turned newel post with a round finial at the top, turned balusters, two per step and a flattened rounded hand rail. Baseboards are high with double rabbetted fields. Beneath the main stairs is a second stair leading to the cellar.

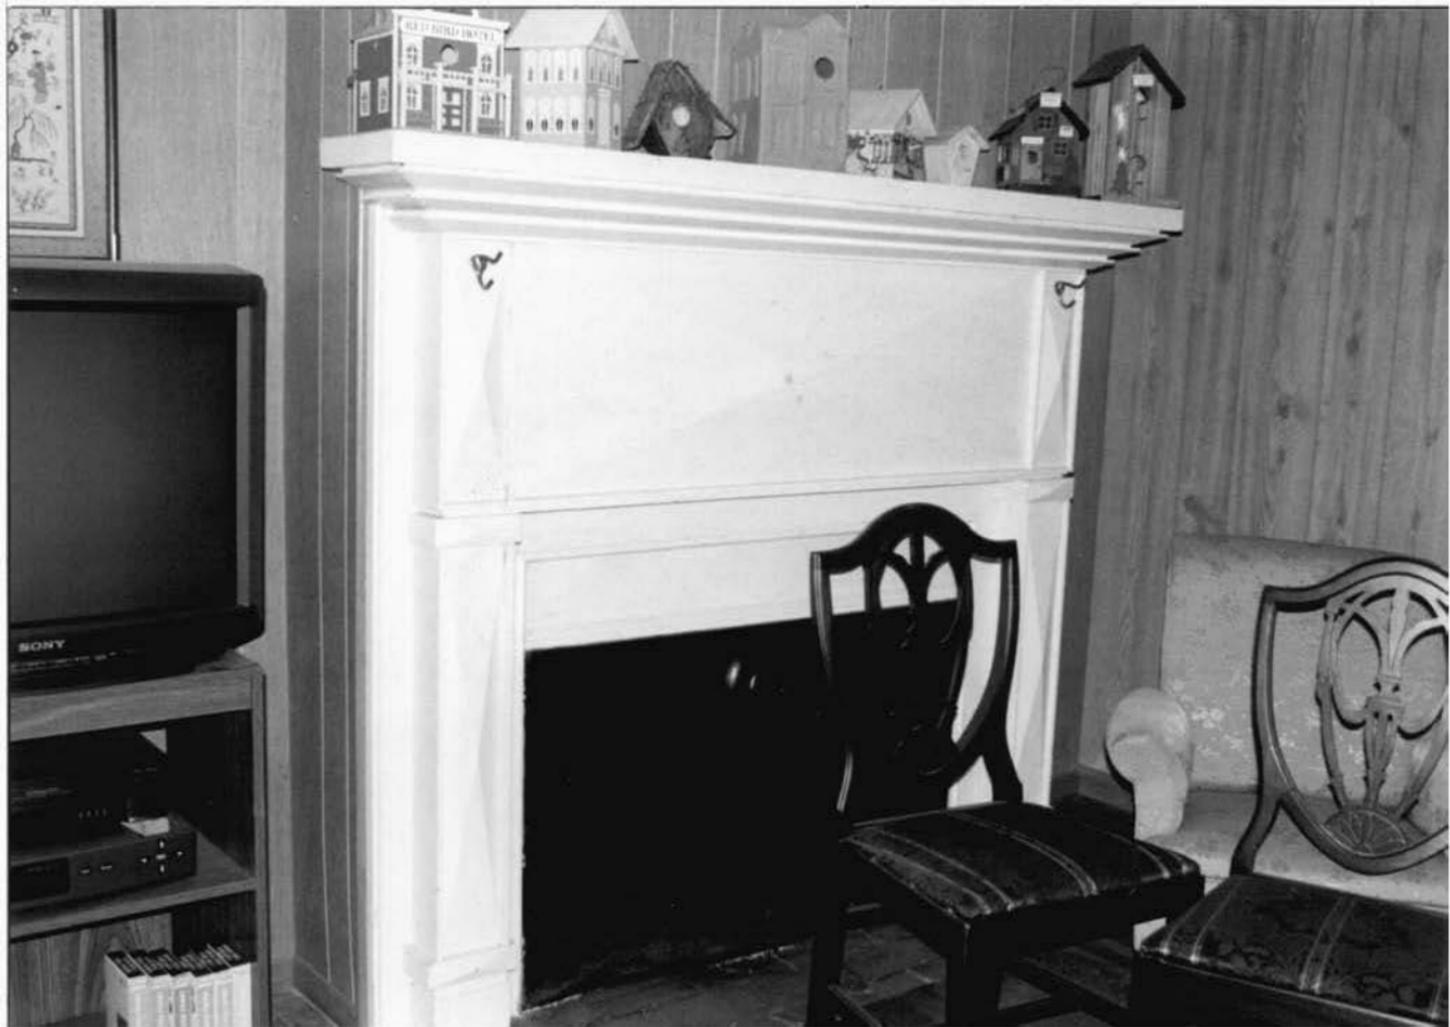
# 6

Interior, parlor (w. room) fireplace

To the north of the stair hall is an area that was once one large parlor room. Some years ago it was partitioned into three rooms, one of which was a bath. Enclosures were made with imitation wood paneling and are clearly evident and did not destroy any of the original fabric which remains intact. The mantelpiece, like others in the house, has a large beveled panel, with similar raised bevels on pilasters. Three courses of Grecian ogee rabbetted molding form the transition from the mantel shelf to its vertical surface.

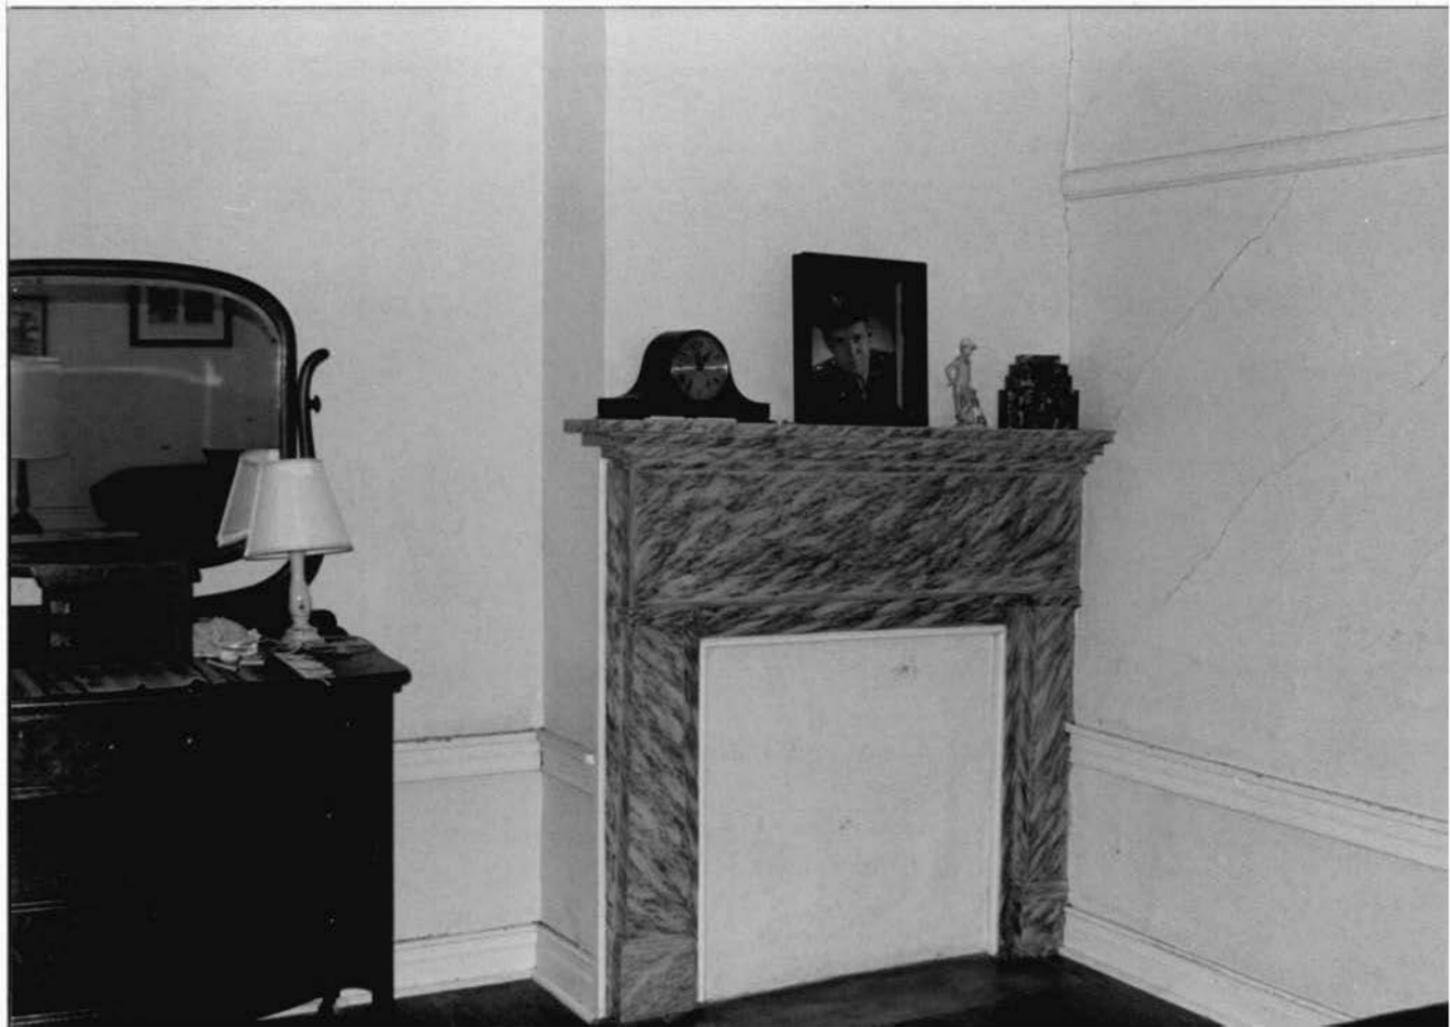
#10

interior, brick house 2nd floor marbled/mantel

of the main section retains its original marbled painted finish on the mantelpiece. Otherwise the mantelpiece is plain with a flat frieze panel, flat pilasters, and wood corbels between the shelf and frieze.

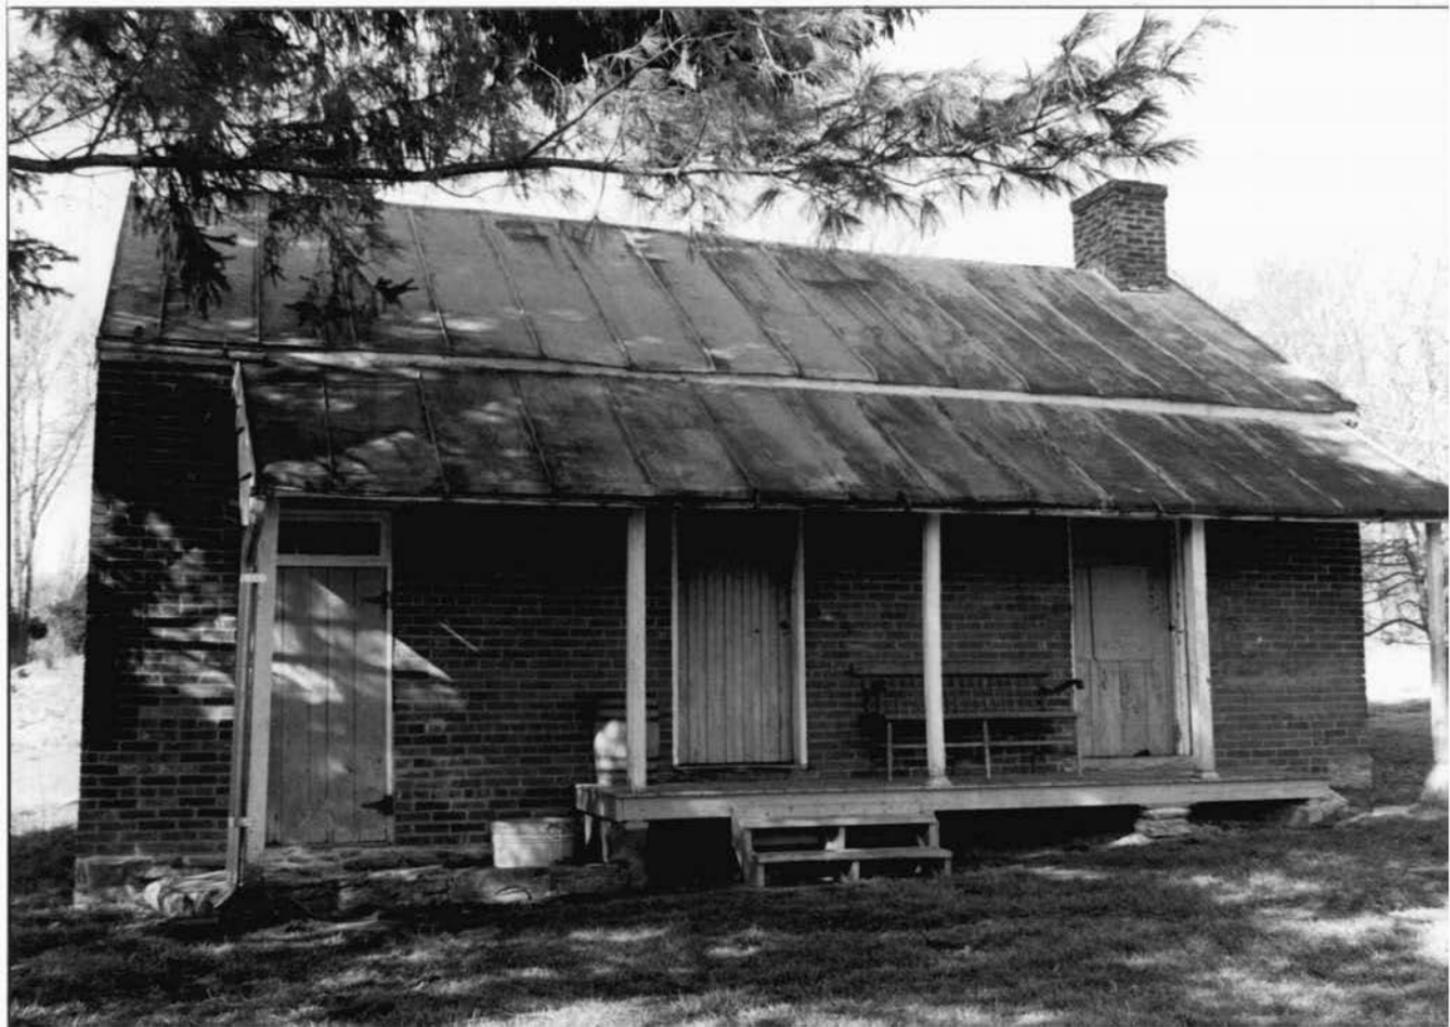
# 11

Brick slave quarters W. view

Just behind and to the south of the main house, close to the rear kitchen entrance are brick **slave quarters**. Slave quarters are extremely rare in Washington County, and these are quite intact. The building is one story high with three bays across the front elevation. The three bays are all entrances, there being no windows in the front wall. The building is constructed of brick laid in common bond and has a standing seam metal roof. A shed roofed porch supported by square posts extends across the front. The porch has decking in front of the two more northerly entrances. There appears to have been some sort of decking in front of the third door but it is no longer present and would have been at a lower level. The easternmost door has a three light transom while the others do not. All doors are board and batten. An inside end brick chimney is located in the north gable. There is no interior fireplace, only a framed-out support for the chimney in the attic. Six over three light windows are located in the north gable wall. One window large enough to accommodate a single six light sash is located in the west wall, and there is evidence of possible windows, later bricked shut, in the east gable wall.

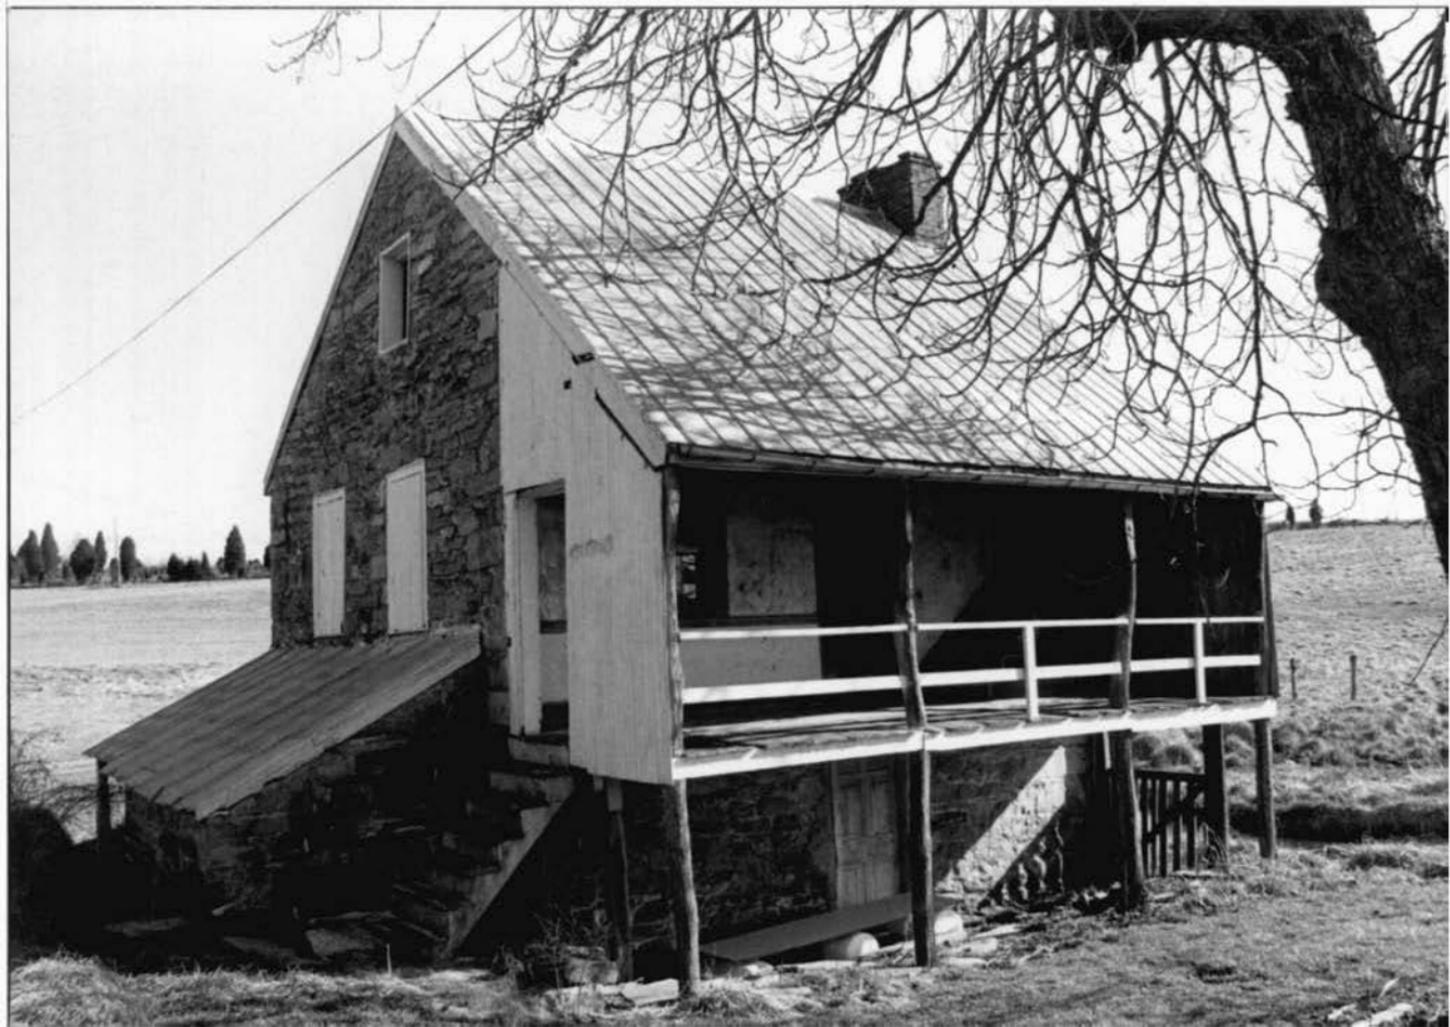
#16

Stone house, NE View

Also part of the complex is a two story **stone house** built over a spring of water. This house is clearly older than the brick residence and may be the original dwelling on the property. It appears to date from ca. 1810 with unusually fine federal period detailing for such a small building. The character of the building is defined by the large spring which runs through and around it. The south (front) elevation has a two-story porch included under the main roof span. The porch may have been extended in depth, and the current rough post supports are not consistent with the refined woodwork on the building. A brick chimney is located inside the east gable end. The main level is the second floor and this area is accessed by wooden steps within the porch structure. The exterior of the building sheltered by the porch at the upper level, although outside, was treated as interior space with plaster walls, chairrail, and baseboard. At the east end of the porch is a staircase leading to the attic area which is unfinished and shows evidence of fire damage.

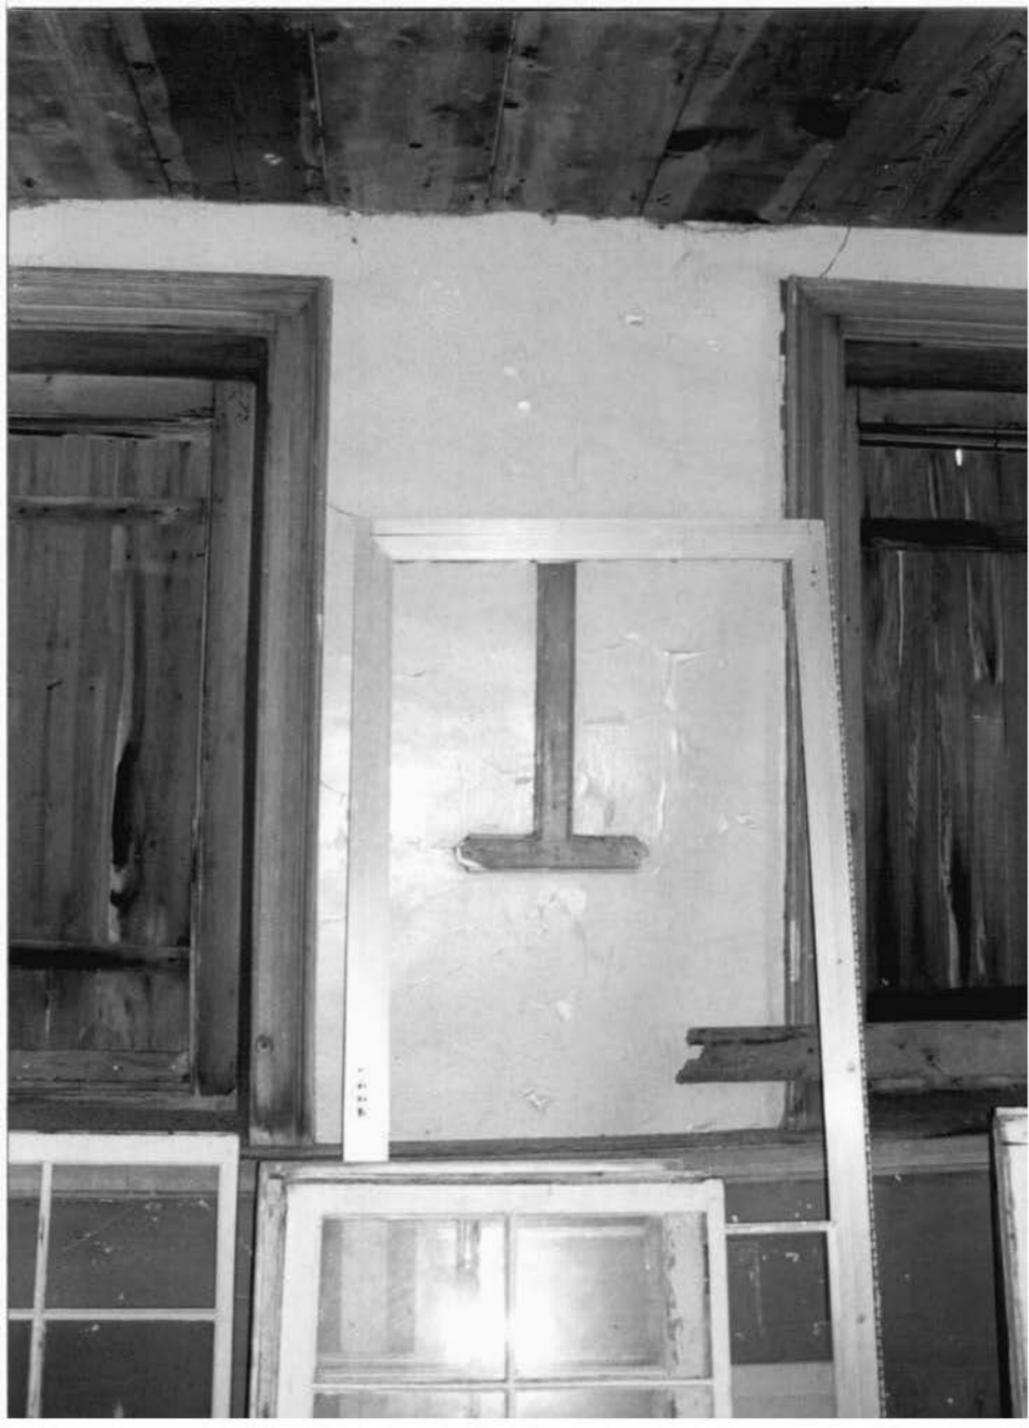
#19

Interior, west room, stone house

The second main level room is at the west end and contains four windows with original trim and chairrail. One refinement in this room is a molded wooden hanging block in the shape of an inverted T, between the two

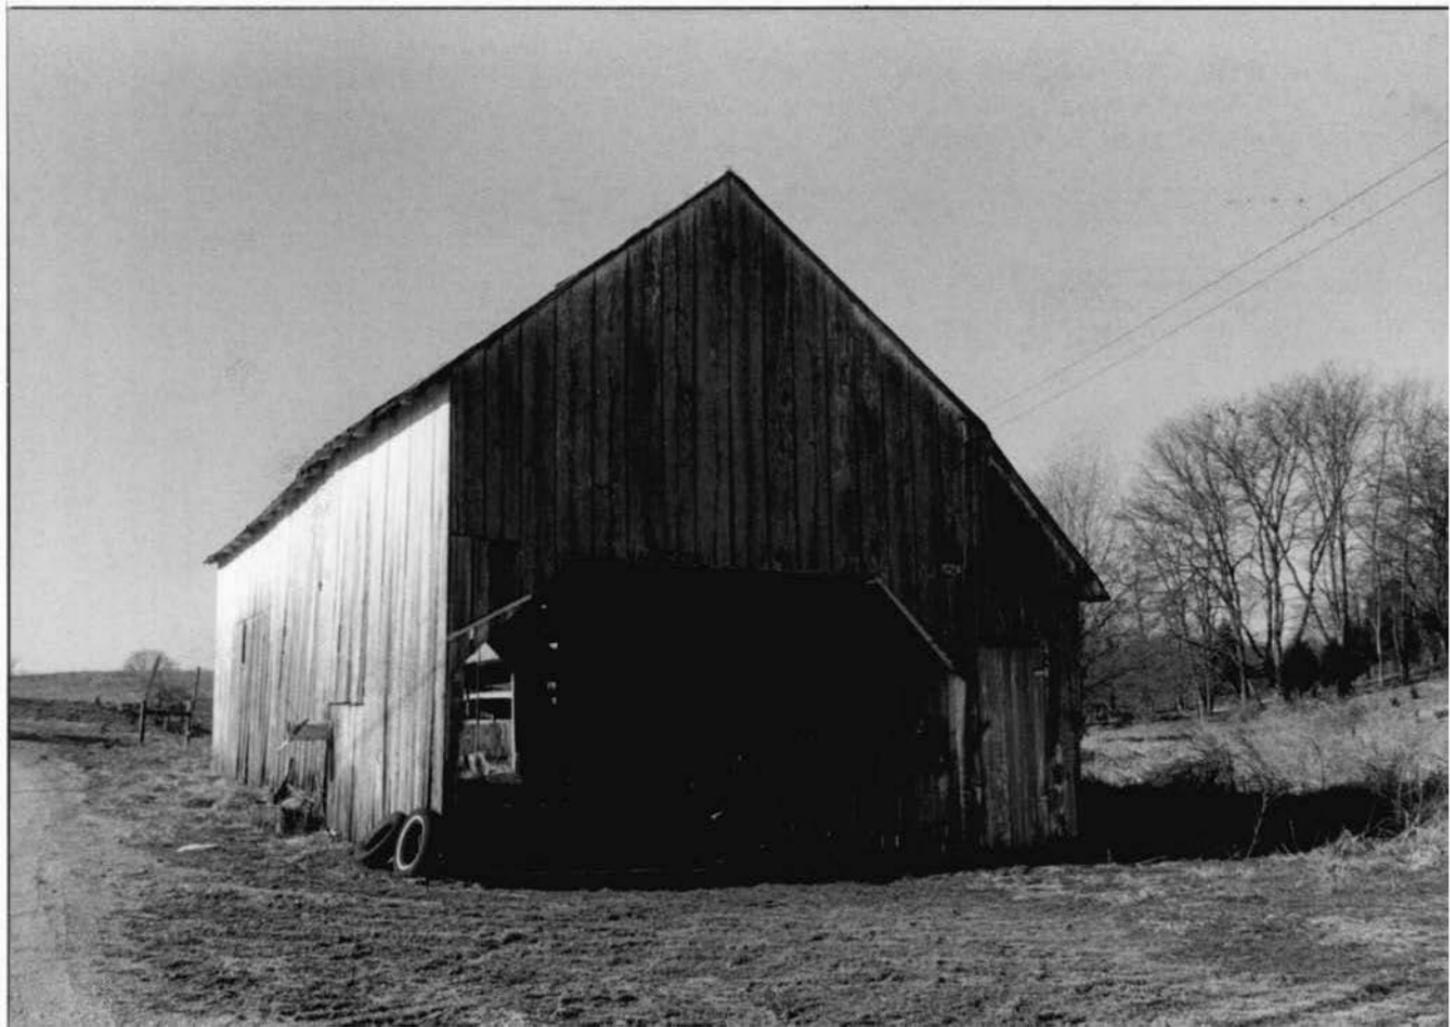
# 21

Wagon Shed, S.W. View

Between the barn and the house are a **log hog barn** and **frame wagon shed**. The hog barn appears to be contemporary with the other buildings, dating from the mid 19th century. It is a v-notched building with an overhang on the west side. The roofing material is standing seam sheet metal with horizontal lapped siding in the gables. Later vertical siding has been applied to the end walls. Built-in troughs are attached near the ground level under the overhang on the west side and steps gave access for humans to the upper level. The wagon shed is framed with vertical board siding and a corn crib along its west side. It also has a standing seam metal roof and appears to date from the mid 19th century.

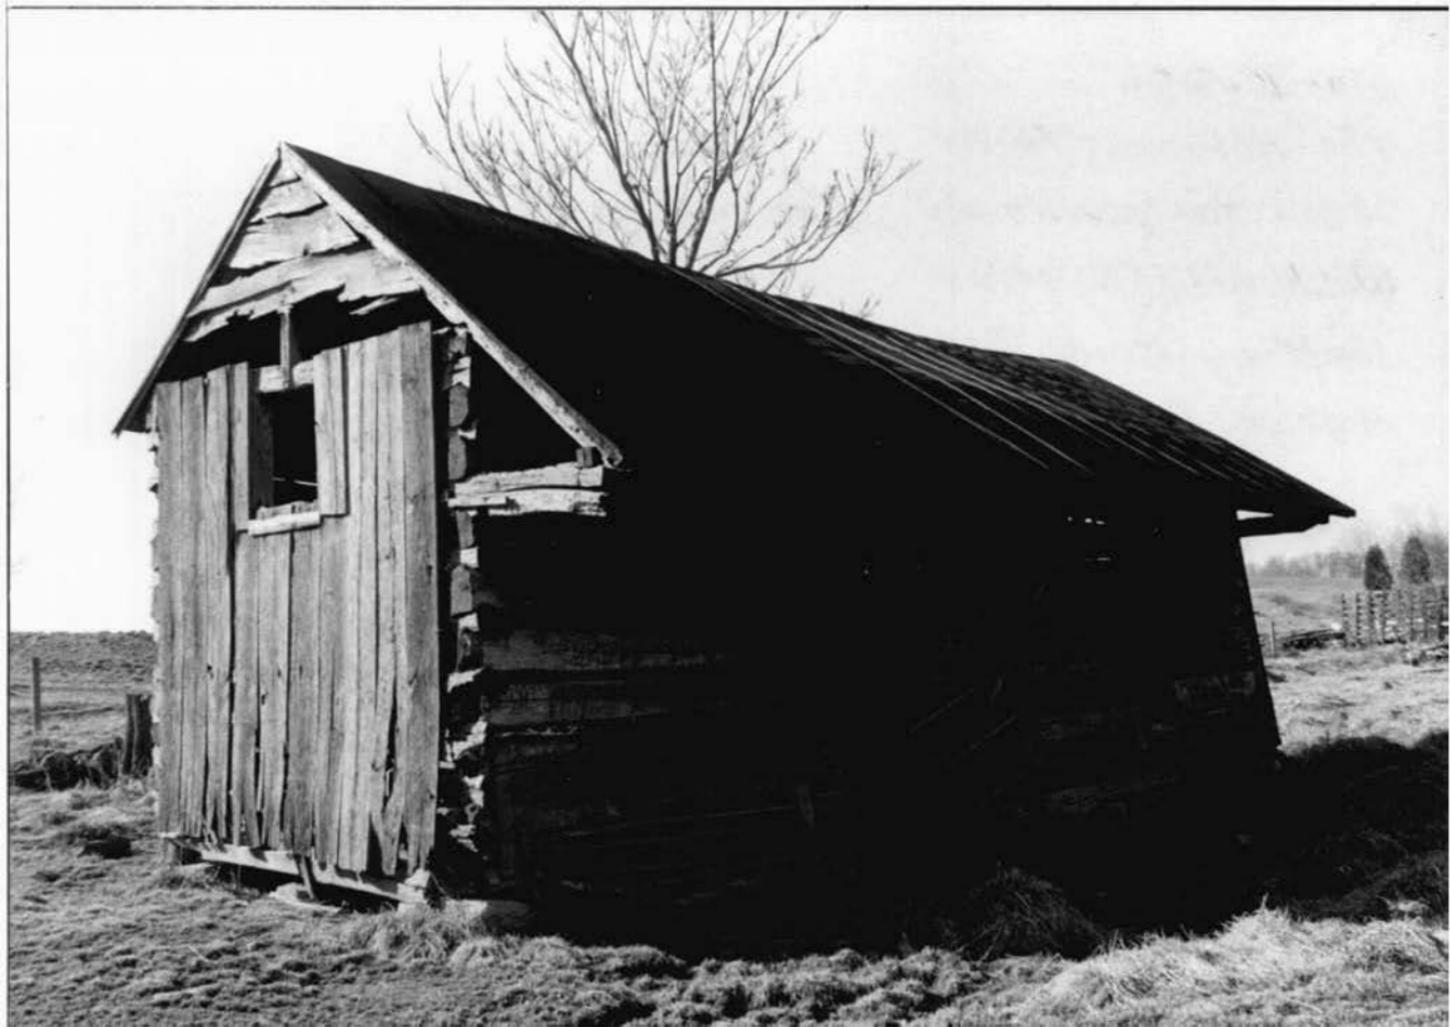
#22

log hog barn, S.E. VIEW
