WA-II-488      Brick Farmhouse

# Maryland Historical Trust State Historic Sites Inventory Form

and/or common Brick farmhouse

city, town Benevola  vicinity of congressional district sixth

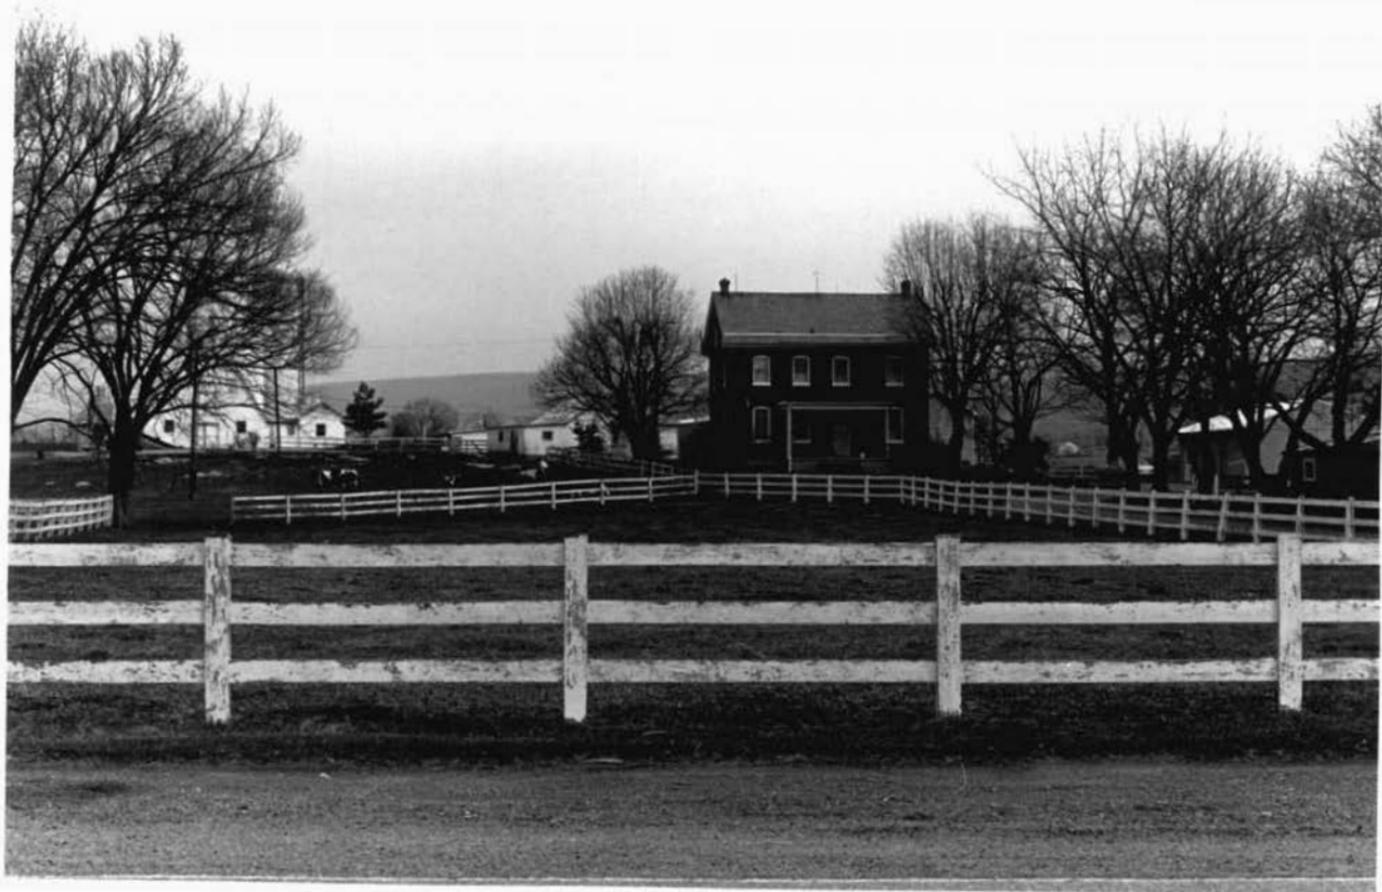
1. Brick Farmhouse           WA-II-488
2. Washington County, Maryland
3. Joe Getty
4. May 1983
5. Maryland Hist. Trust, Annapolis, Md.
6. West elevation; camera facing east
7. 1/1
