# Maryland Historical Trust

## State Historic Sites Inventory Form

historic Frame house

Survey No. WA-III-076

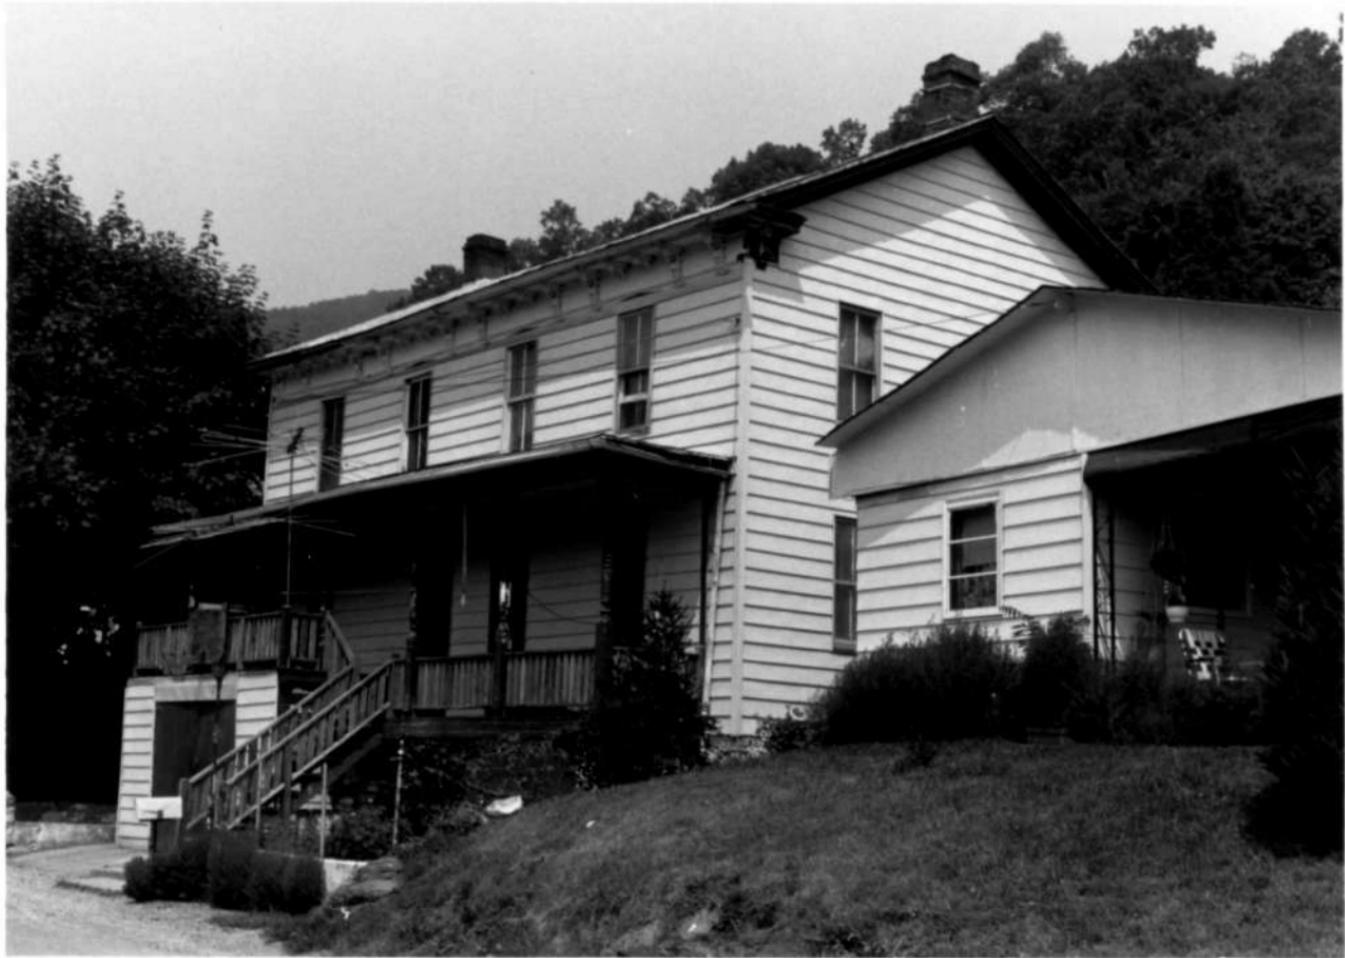
1. WA-III-076
2. Washington Co., Md.
3. Joe Getty
4. ~~April 1985~~ 7/82
5. Md. Hist. Trust, Annapolis, Md.
6. South elev. (camera facing north)
7. 1/1

The frame house is a two-story frame structure constructed in a rectangular plan. It is a four-bay by two-bay structure covered in modern aluminum siding. The main facade is symmetrically arranged with two entrances in the two central bays of the main story. Four-over-four sash windows are located in the outer bays of the first story and the four bays of the second story. Victorian-style ornamentation includes an ornamental bracket cornice and a full-length, one-story porch with turned posts. The structure appears to date from the late 19th century.

The two-story structure is constructed of frame covered in a modern aluminum siding on a fieldstone foundation. The main facade is symmetrically arranged with entrances in the two central bays. Two-over-two sash windows are located in the outer bays of the first story and the three bays of the second story. The full-length, one-story front porch is elevated above the foundation level by brick plinths. A wood stair with the slat railing leads up from ground level to the porch. One section of the porch sits slightly higher than the other section. The porch roof is supported by turn posts. The front cornice includes a bracket frieze with smaller bracket dentils. The cornice turns the corner one bracket length. The gable ends contain two two-over-two sash windows on each story. The roof is covered in sheet metal. It has interior-end brick chimneys with corbelled caps.
