# Maryland Historical Trust State Historic Sites Inventory Form

historic Stone house

18932 Sandy Hook Road JKC 12/1/05

Survey No. WA-III-080

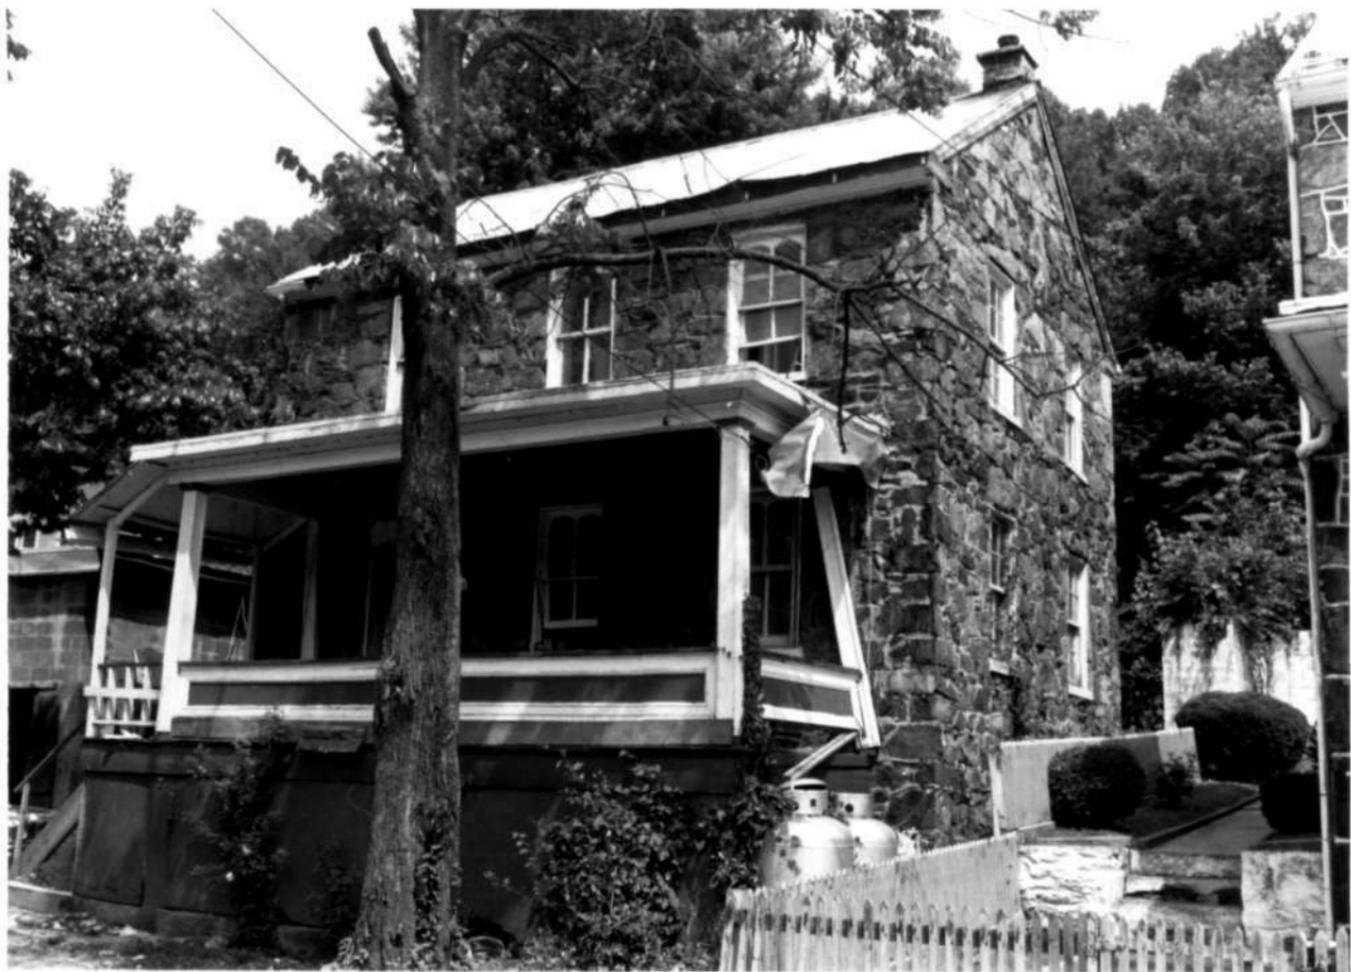
1. WA-III-080
2. Washington Co., Md.
3. Joe Getty
4. ~~April 1983~~ 7/82
5. Md. Hist. Trust, Annapolis, Md.
6. South elev. (camera facing north)
7. 1/1

The stone house is a two-story stone structure built in a rectangular plan. It is three-bays by two-bays constructed in rough-laid stone with large quoins. The main facade has a side entrance plan. The two-over-two sash window is ornamented by round-arch upper panes. The gable roof has a boxed cornice. The structure appears to date from the mid-19th century.

The two-story structure is constructed of rough laid stone with large quoins. There is a full-length, one-story porch with square posts and panelled railing. The stairs to the porch are located on the west end of the porch. There is a side entrance with small transom. Late 19th century window sash is on the main facade containing two-over-two sash with round-arch upper sash. In the two bays on each story of the gable ends are six-over-six sash windows. The gable roof has a boxed cornice. A brick chimney rises interior-end from the east gable end.
