Survey # WA-III-132
Street Address 4327 Main Street
Town, State Rohrsersville, Maryland 21779
private X, public _____

Approximate date Ca. 1880s

MARYLAND COMPREHENSIVE PRESERVATION PLAN DATA

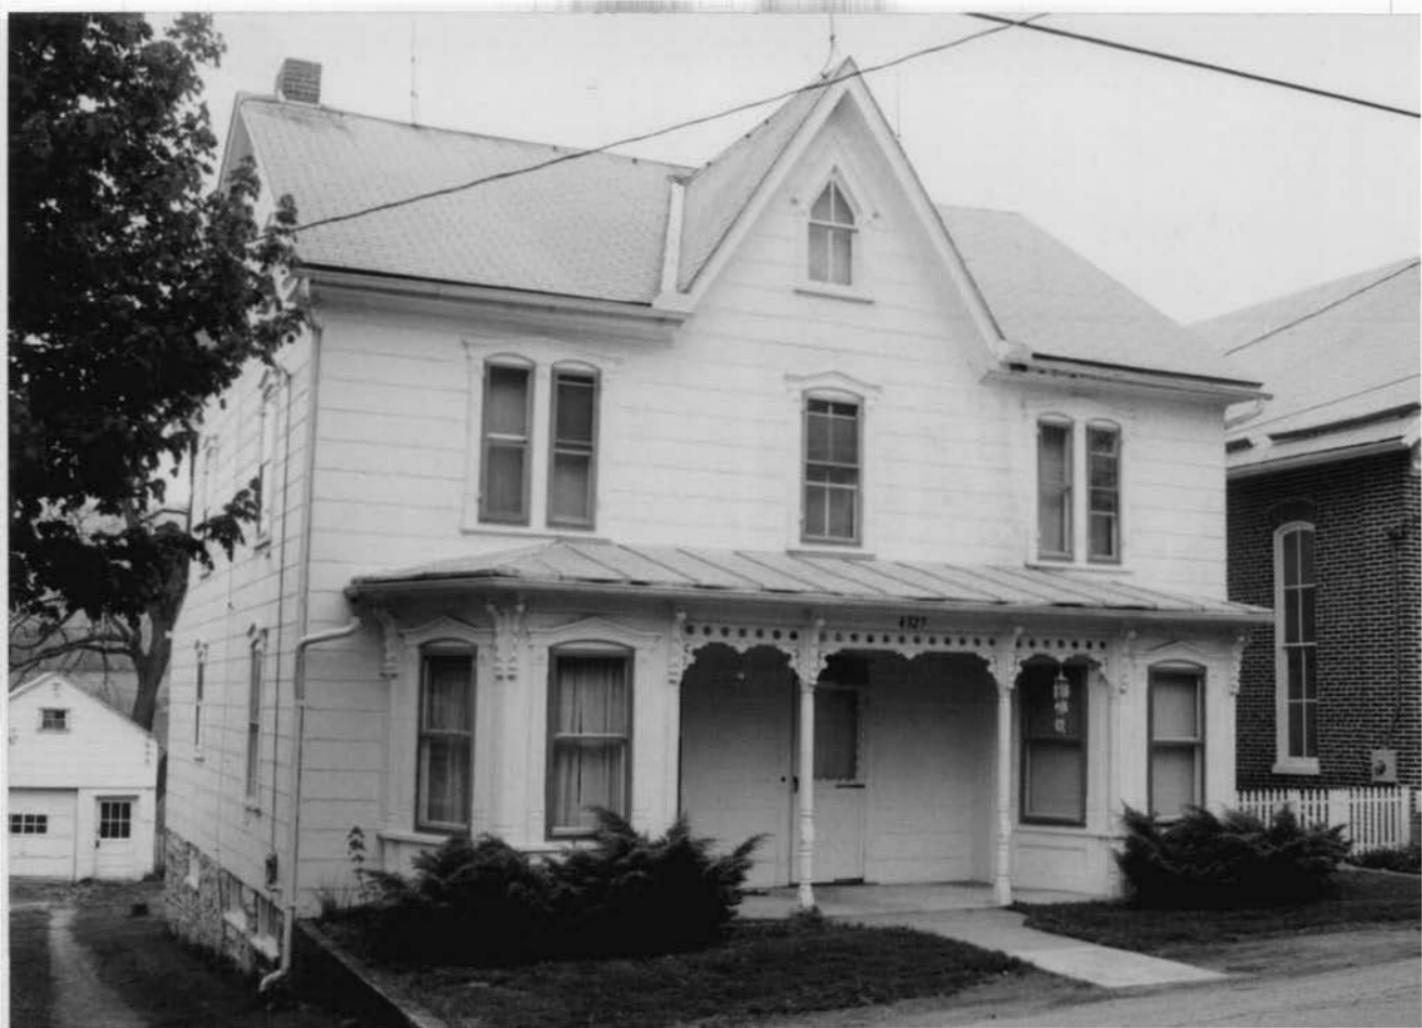
#9 of 43

Located on the east side of Main Street is this two story, three bay light frame house covered with asbestos shingle siding. It rests on field stone foundations and is distinguished by a central cross gable, two semi-hexagonal projecting bays, and a fancy porch with turned posts and brackets. Windows have single pane or two over two sash and are trimmed with architraves with pointed or peaked tops. The window in the cross gable has two light sash with the upper sash being steeply pointed. The two end bays of the front elevation have doubled windows at the second story level and semi-hexagonal projecting bays at the first story. The projecting bays are incorporated into the porch structure, and are trimmed with brackets to match those that are attached to the porch posts. The house is influenced by the Victorian Gothic style although it is a subdued and restrained example. Behind the house is a gable fronted concrete block garage which is non-contributing. The date attribution for this house is based on the fact that it does not appear on the 1877 Atlas map, it is of light frame construction and its decorative trim features are associated with the 1880s.

House, SE view
