Survey # WA-III-136
Street Address 4335 main Street
Town, State Rohrerstown, Maryland 21779
private X, public _____

MARYLAND COMPREHENSIVE PRESERVATION PLAN DATA

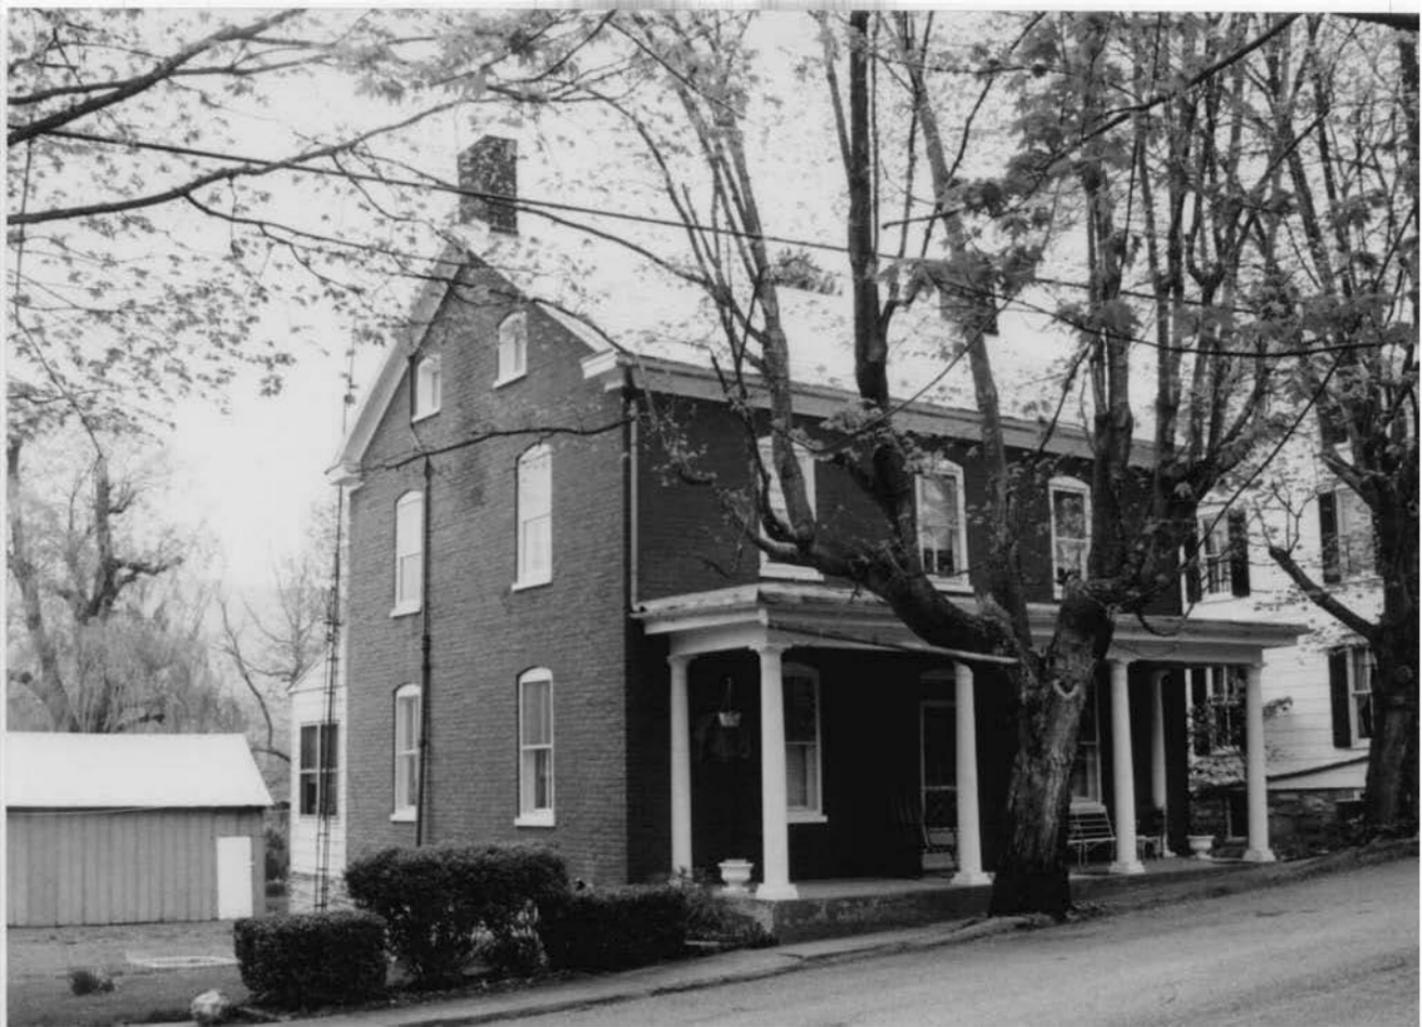
WA-III-136

Located on the east side of Main Street is this brick two story, three bay house resting on fieldstone foundations. Bricks are laid in common bond and are painted dark red. Segmental arches of brick form the tops of the openings. Windows have two over two pane sash. Wooden infill within the segmental arches is trimmed with cut out floral designs. The front entrance is located in the center bay of the front elevation and includes a two light transom. Across the front is a porch supported by round Tuscan Doric columns. Brick chimneys are located inside the gable ends. An enclosed shed roofed porch is located at the rear of the house. The roof is covered with pressed tin shingles. A frame shed at the rear of the house has been covered with aluminum siding. It is considered to be a contributing building since it rests on stone foundations. The ca. 1900 construction date is based on the segmentally arched windows, porch, overall form and the fact that it does not appear on the 1877 Atlas map.

House, SE view
