Maryland Inventory of Historic Properties number: WA-IV-261

Name: 21032/MD66 OVER BEAUFORT CREEK

MARYLAND INVENTORY OF HISTORIC BRIDGES  
HISTORIC BRIDGE INVENTORY  
MARYLAND STATE HIGHWAY ADMINISTRATION/  
MARYLAND HISTORICAL TRUST

SHA Bridge No. 21032 Bridge name MD 66 over Beaver Creek

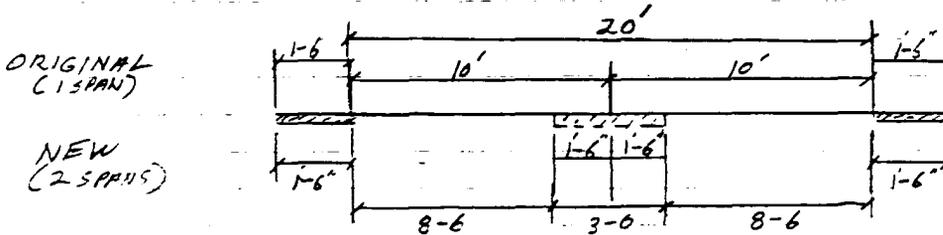
New span length for 2 simple spans assuming the same bearing area as original design:

$$\text{NEW SPAN LENGTH} = (8'-6") + (1'-6") = 10'-0"$$

$$S = 10.0'$$

TO CONVERT THE 20' SLAB INTO TWO 10' SLABS CUT THE CONCRETE RAILING AT  $\frac{1}{2}$  OF THE BENT AND SAW CUT 2"-3" OF THE TOP OF THE CONCRETE SLAB. THIS WILL CONTROL THE LOCATION OF THE CRACK LETTING THE SLAB BECOME TWO SIMPLE SPANS ON ITS OWN. (NO TOP REINFORCING ACCORDING TO PLANS)
