WI-388
The Bank of Delmar
Delmar
Private

RESOURCE NAME: The Bank of Delmar

MHT INVENTORY NUMBER: WI-388

**Maryland Historical Trust
State Historic Sites Inventory Form**

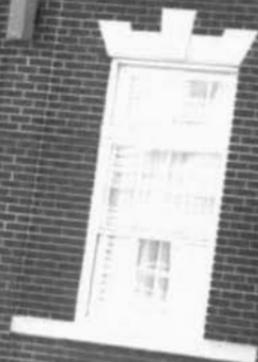
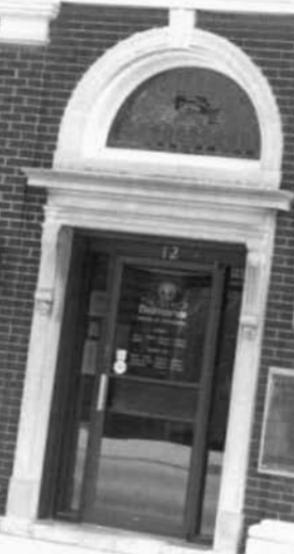
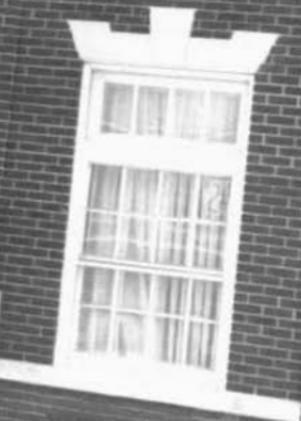
THE BANK OF DELMAR

Built around 1920, the single-story brick bank building is supported on polished granite base, and it is surrounded, above as well as to each side, by mid to late twentieth century brick additions. The historic three-bay front is laid in stretcher bond, and the three-bay wall is defined by four brick pilasters featuring stone capitals and bases.

The center bay is filled with a round arched door opening framed in a neoclassical surround and arched transom. The door surround features carved consoles that visually support the molded entablature. Fixed atop the entablature is the arched transom defined by a molded stone surround fitted with a center keystone. A leaded glass transom includes "Est. 1896" within the colored glass design. The front door is a modern glass replacement.

Located to each side are large sized window openings filled with eight-over-eight sash windows topped by four-light transoms. Each window opening features a stone still and a stone jack arch. The jack arches have articulated keystones and end blocks. Below each window is an inset brick panel. Stretching across the top of the first story is a stone entablature which is inscribed, "The Bank of Delmar." The former parapet wall rises atop the entablature and is accented by a stone cap. The stretcher bond brick walls rise atop the early twentieth century bank building.
