WI-624  
Union Church  
Salisbury vicinity  
Public worship

# Maryland Historical Trust Maryland Inventory of Historic Properties Form

Inventory No. WI-624

historic Union Methodist Protestant Church  
other Union Church

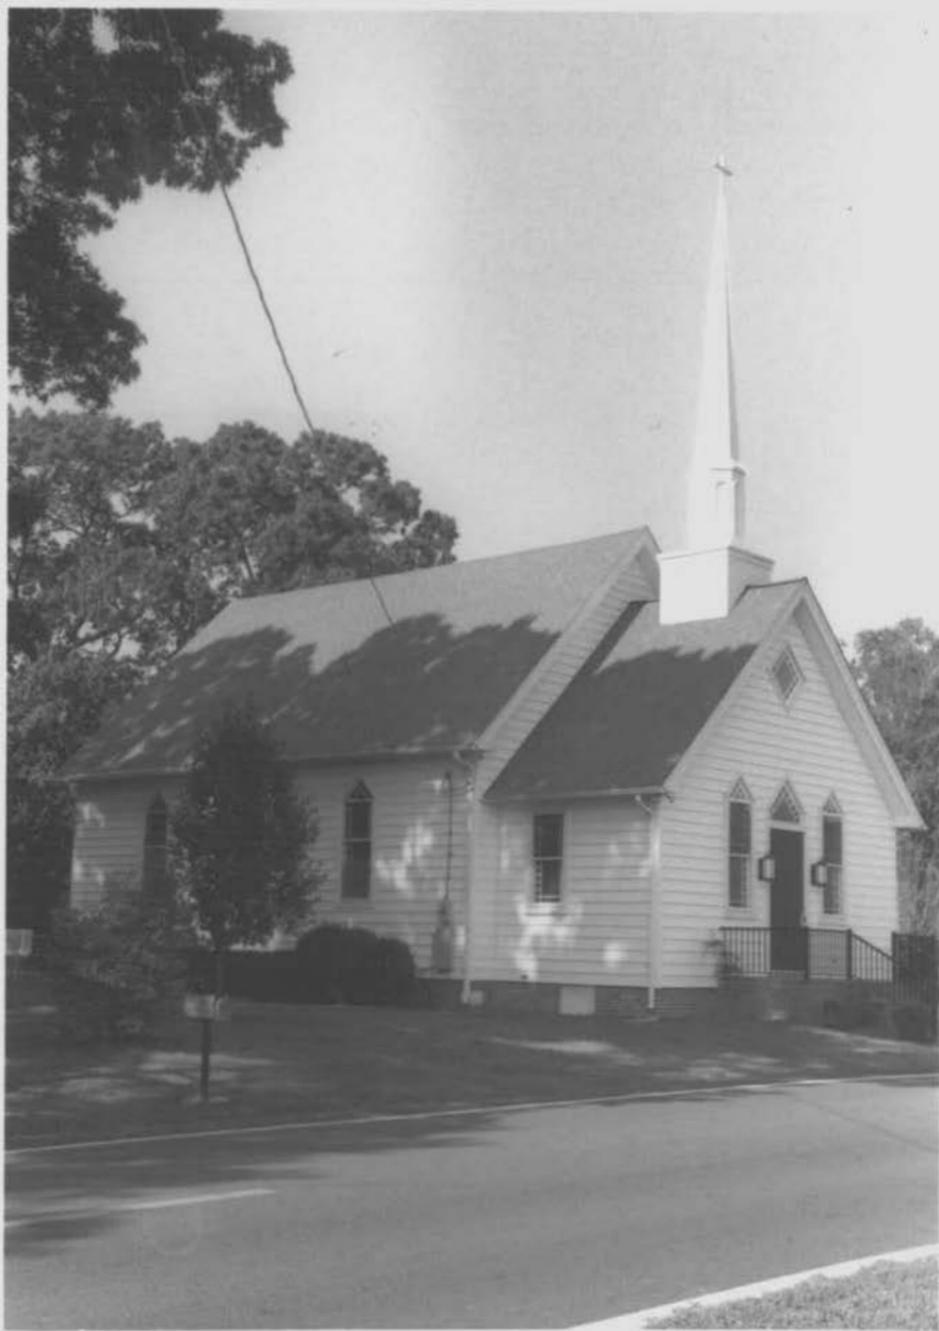
1 OF 5

The northeast (main) elevation of the 1904 church is largely covered by the shorter single story vestibule addition. Fixed in the northeast corner of the addition is a marble datestone inscribed "Union M. P. Church, 1904." The modern vestibule addition has reused colored glass, pointed arch window to each side of the entrance, which is topped by a pointed arch colored glass transom. Fixed in the gable end is a diamond shaped colored glass window.

NORTHEAST VIEW.

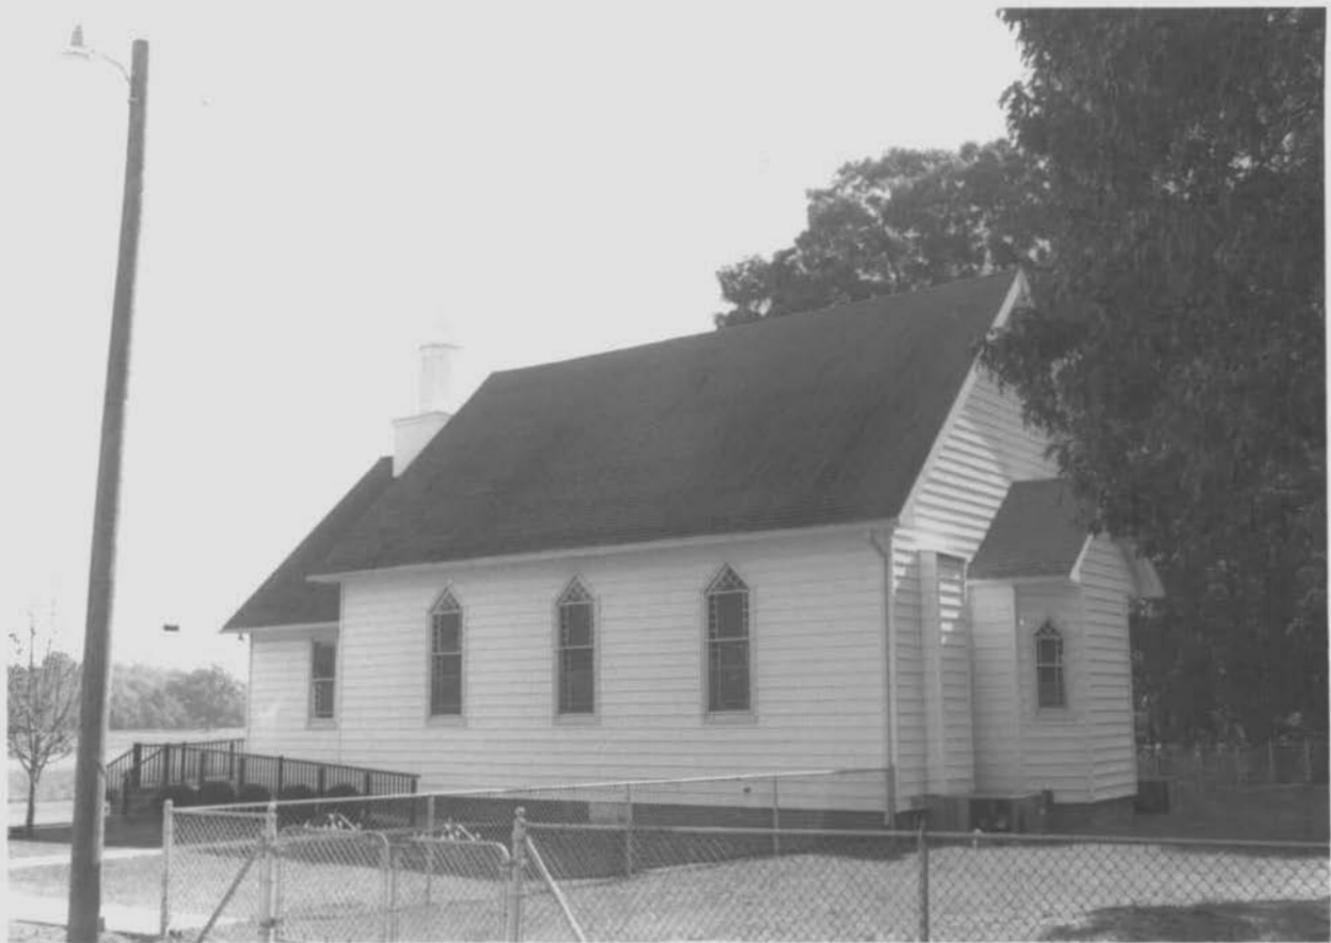
2 of 5

The southwest (rear) wall is defined by a shorter single-story, five-sided apse pierced on each side with pointed arch, colored glass windows.

Southwest Elevation

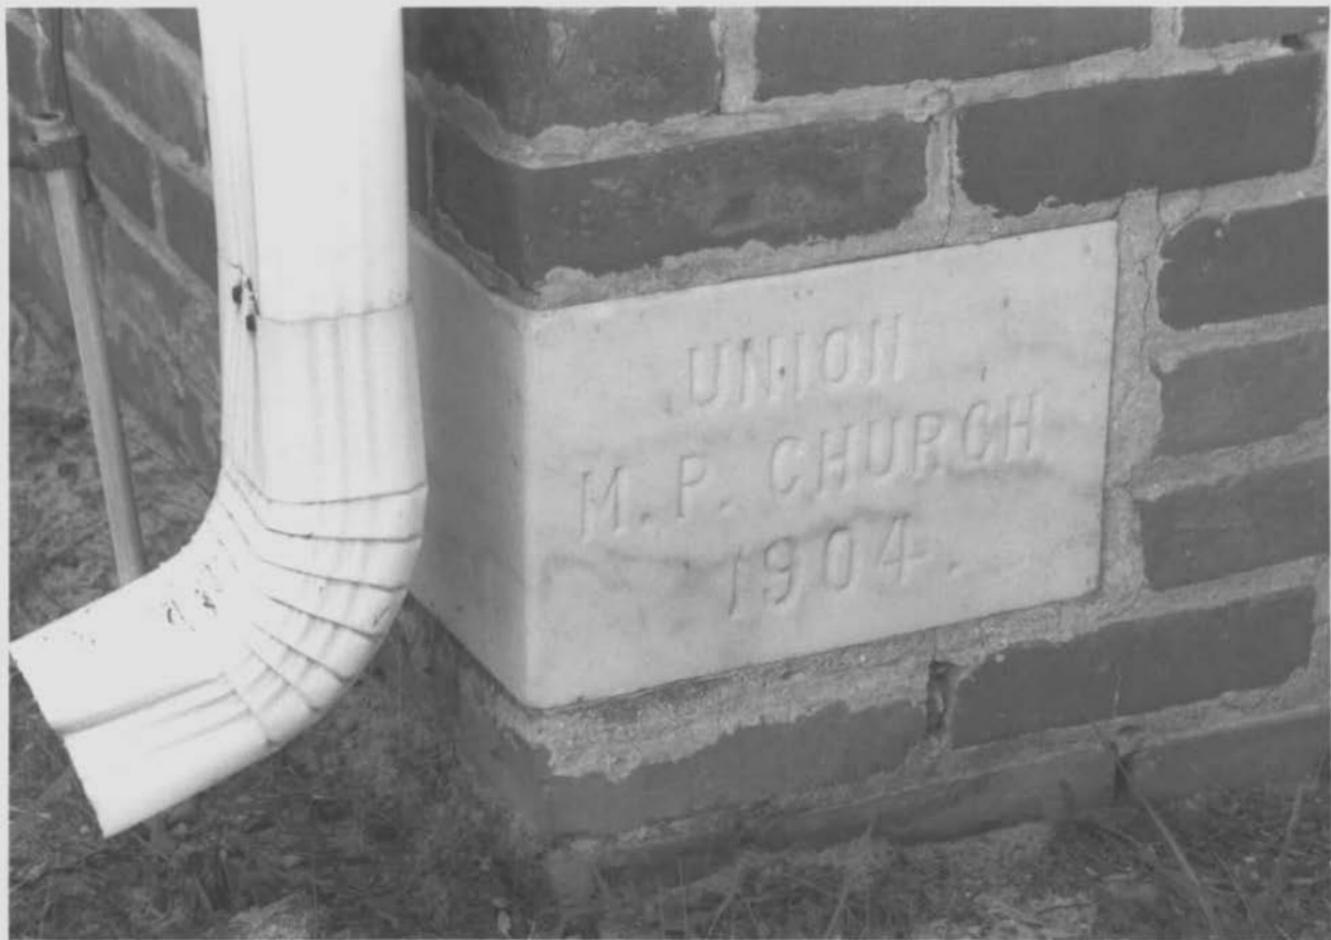
3 of 5

UNION  
M. P. CHURCH  
1904.

DATESTONE, NORTHEAST CORNER

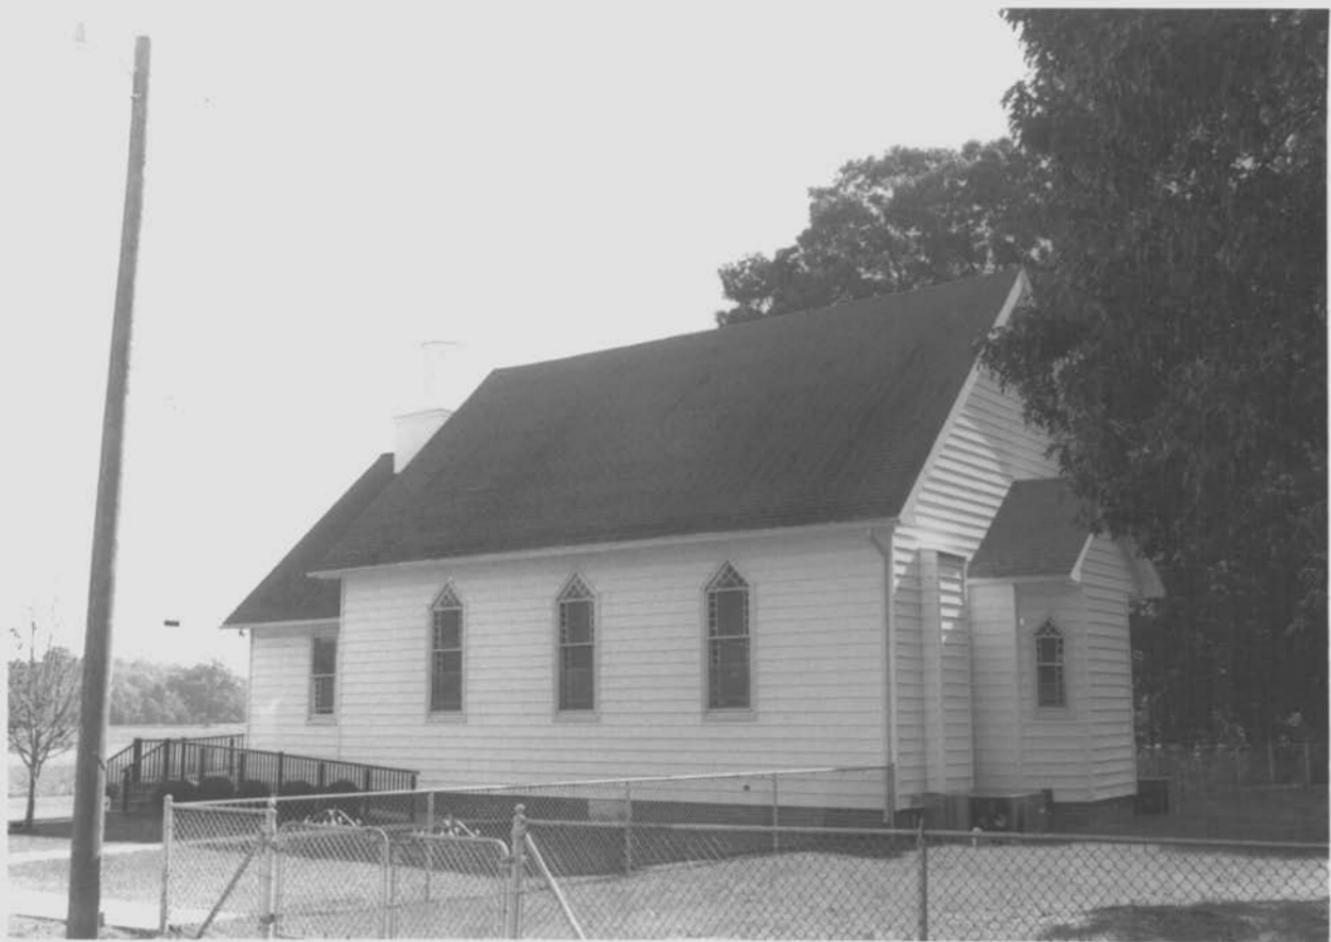
5 of 5

Southwest Elevation
