NATIONAL REGISTER OF HISTORIC PLACES INVENTORY -- NOMINATION FORM

St. Martins Church, Worcester Parish

Old St. Martins Church

Old St. Martins Church
Worcester County

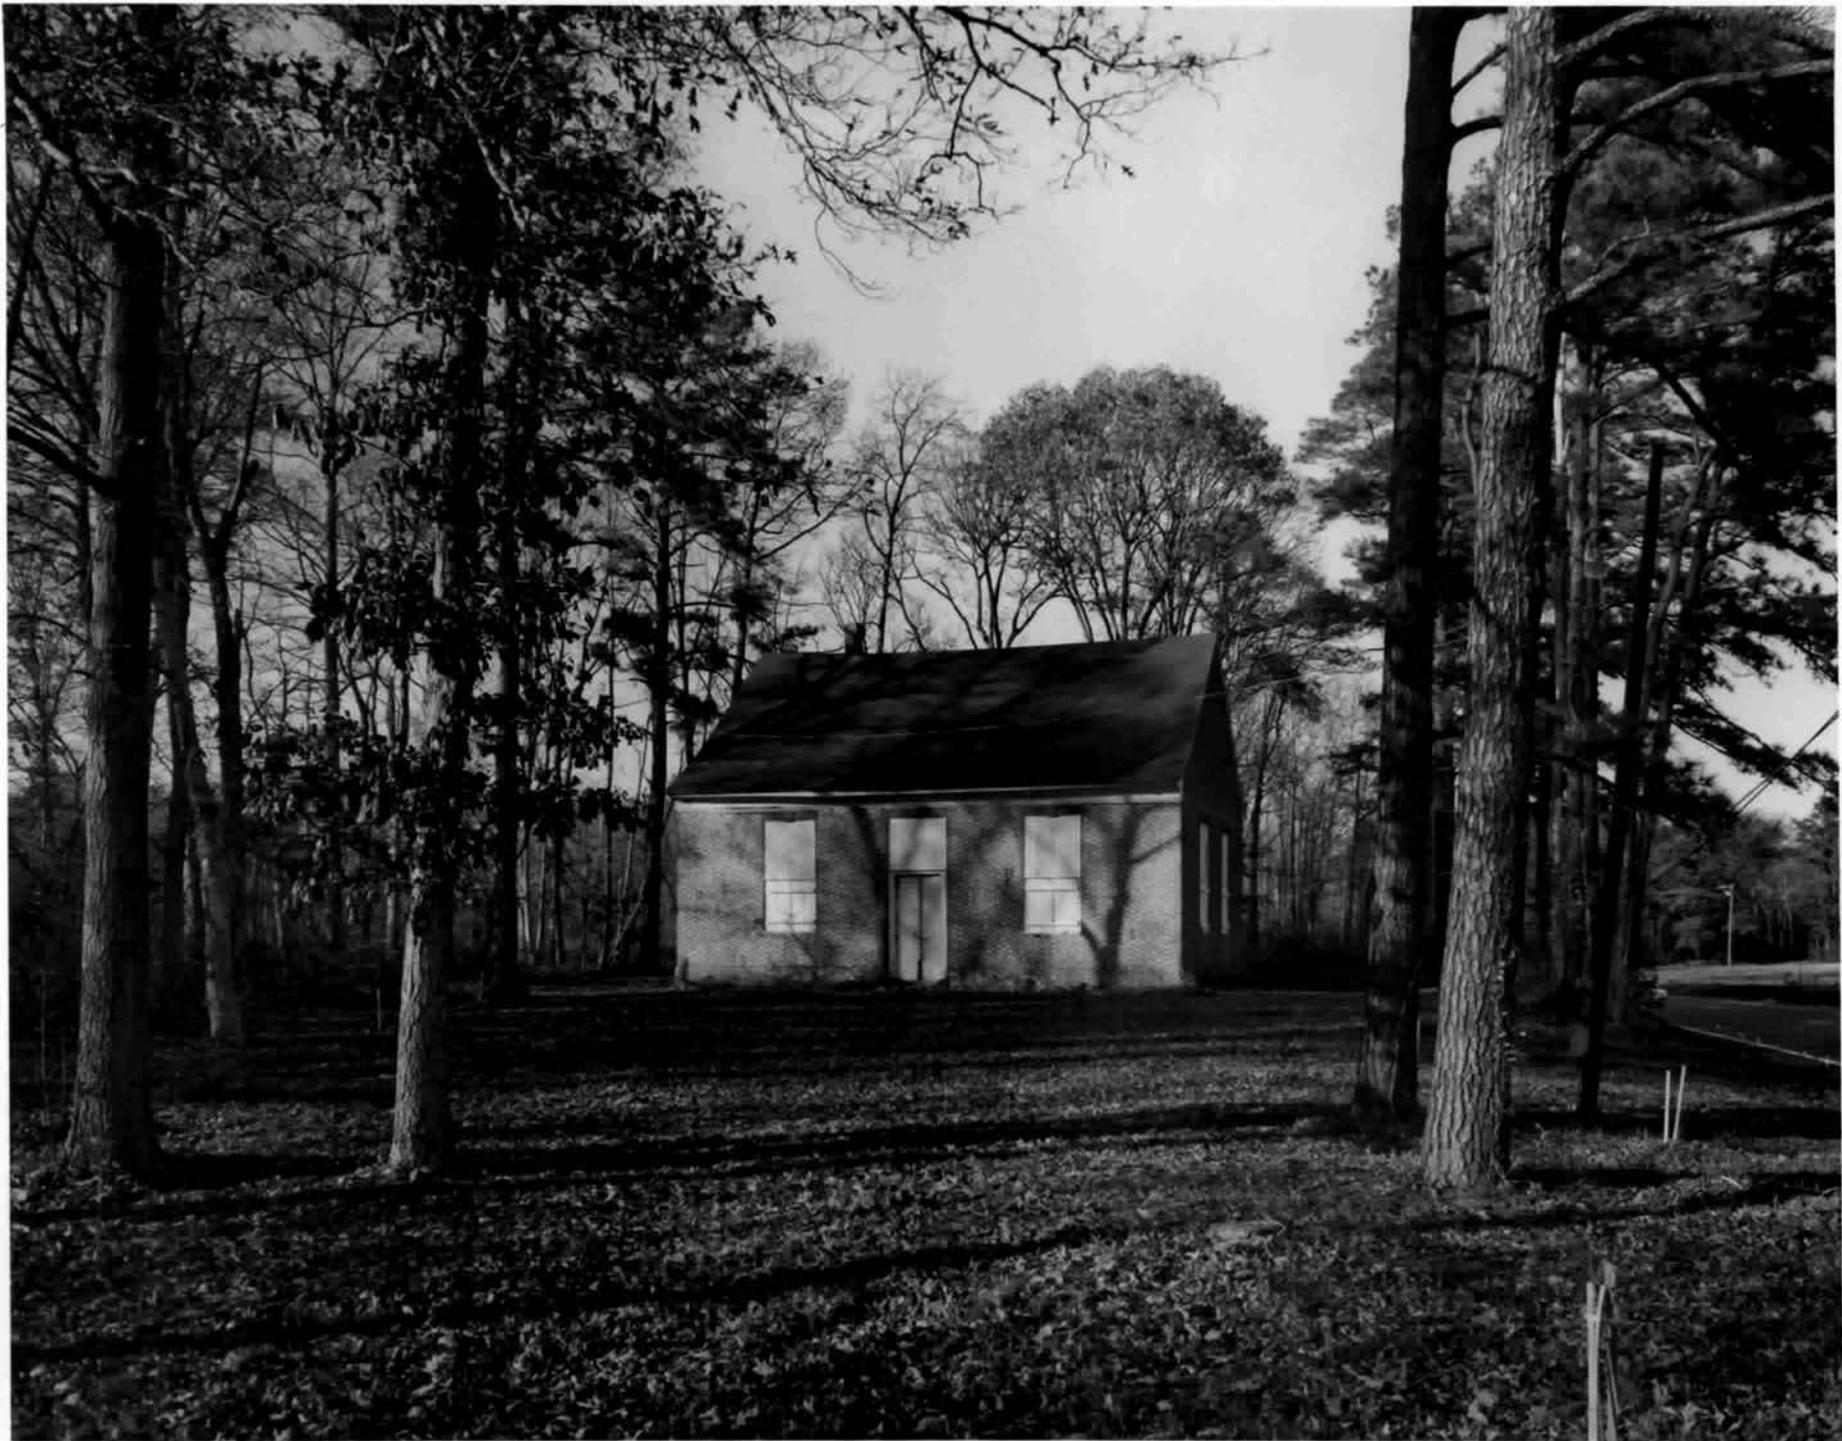
SOUTH ELEVATION

The south facade is three bays long with a double batten door and transom (now boarded up) in the center bay. The two flanking windows are now closed on the lower half by batten shutters with strap hinges and are completely boarded over^m the upper half. The lintels above the windows and doors are of gauged brick, and those above the windows have a gauged brick keystone. The west facade also contains an entrance with double batten doors. At gallery level is another boarded window. One of the unusual features of the building is the flat arches above the entrances which have an ogee ground into the bottom of the arch similar to those at Holly Hill, Anne Arundel County, Maryland.

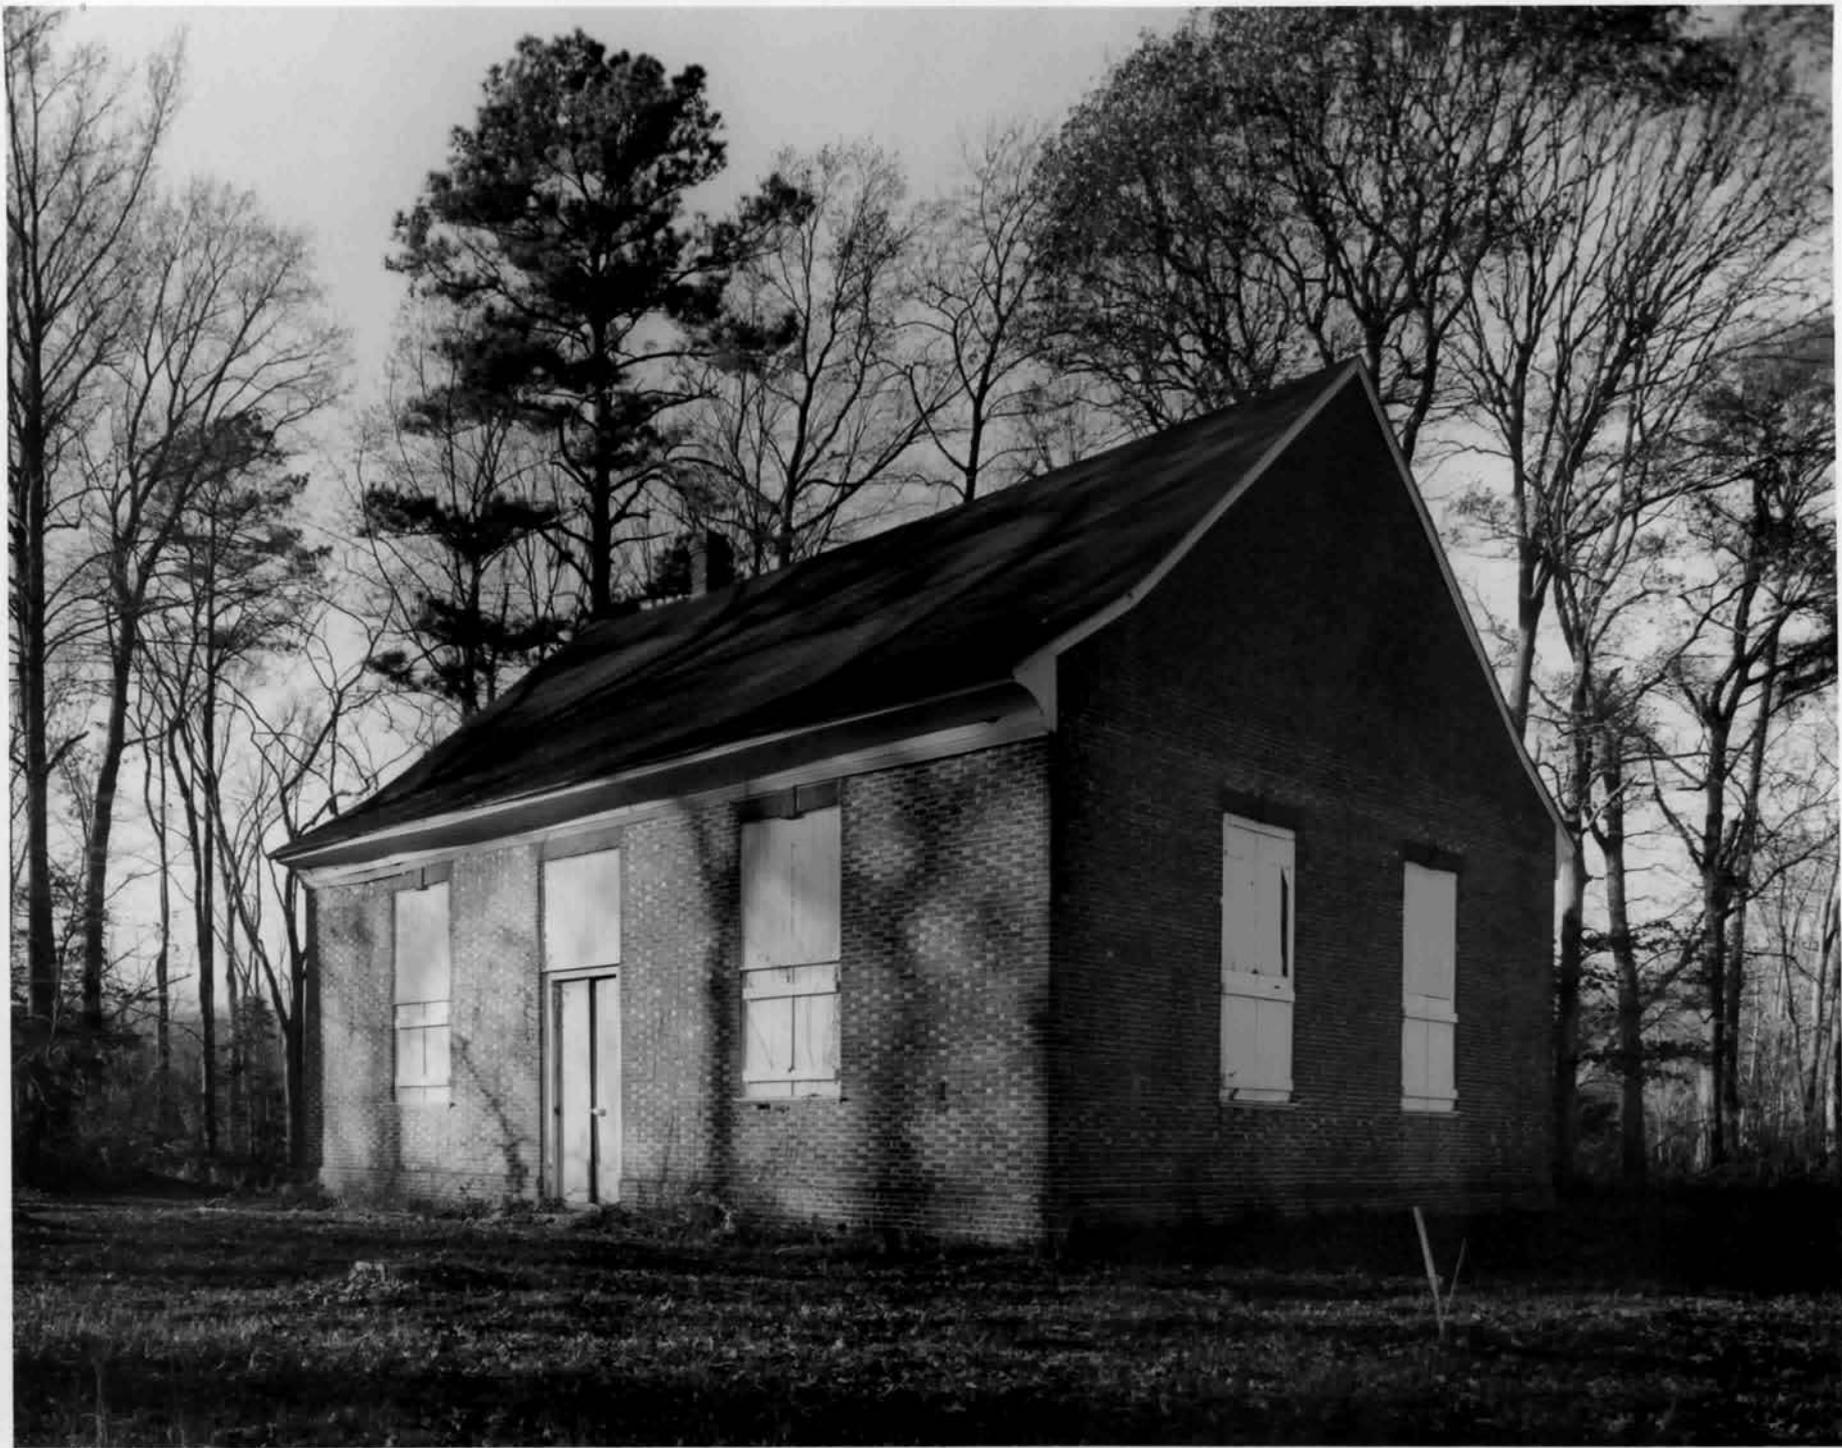
SOUTHEAST ELEVATION

The north and east sides have two windows each exhibiting the same treatment as the south facade, with keystones in the gauged flat arches and shuttered and boarded windows. The east gable appears to have been rebuilt with brick of a more modern date.
